Re: Permit Number: SPRRN220319
Spacing and Notching of Corridor Wall Studs

STEAMBOAT HOTEL AND LODGE STUD REPAIR DETAIL HOTEL 3195 SOUTH LINCOLN STEAMBOAT SPRINGS, COLORADO 80477	DATE	1-11-23

ALPENGLOW ENGINEERING SOLUTIONS, INC. Consulting Structural Engineers	PROJECT	22-050	SHEET S-1 1 OF 1
	DRAWN	BFS		CHECKED	BFS	
	FILE			SCALE	NOT TO SCALE

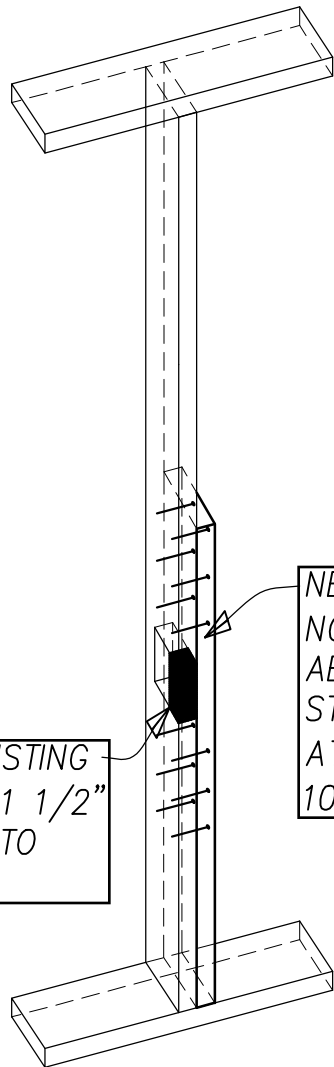
Several of the wood studs in the main level corridor were notched for a 2 3/8" diameter electrical conduit. The notch for the conduit was approximately 4 1/2" tall and 4" deep and repairs are required for the studs to safely support the imposed loading.

Repairs should consist of adding a 1 1/2"x 1 1/2" wood filler piece in the front of the notched stud and sistering a new partial stud to the existing stud. The new stud should run from the bottom plate and extend a minimum of 8" above the notch. The new stud should be attached to existing stud w/ (6) 10d nails above and below the notch (see attached drawing).

INFILL FRONT OF EXISTING NOTCH W/ 1 1/2" x 1 1/2" WOOD FILLER, GLUE TO ADDED STUD

NEW STUD SISTERED TO EXISTING NOTCHED STUD, EXTEND MIN. 8" ABOVE NOTCH, NOTCH BACK OF STUD TIGHT FOR CONDUIT, AND ATTACH TO EXISTING STUD W/ (6) 10d's ABOVE AND BELOW NOTCH
