**NORTHWEST COLORADO CONSULTANTS, INC.  
FIELD REPORT**

<b>Project:</b> Partovi Townhomes	<b>Project No.:</b> 19-11700	<b>Date:</b> 10/23/23
<b>Location:</b> Steamboat Springs, CO	<b>Report No.:</b> 1-P	<b>Time:</b> 6.5
<b>Client:</b> Sunscope, LLC		<b>Mileage:</b> 11
		<b>Engr. /Tech:</b> EL

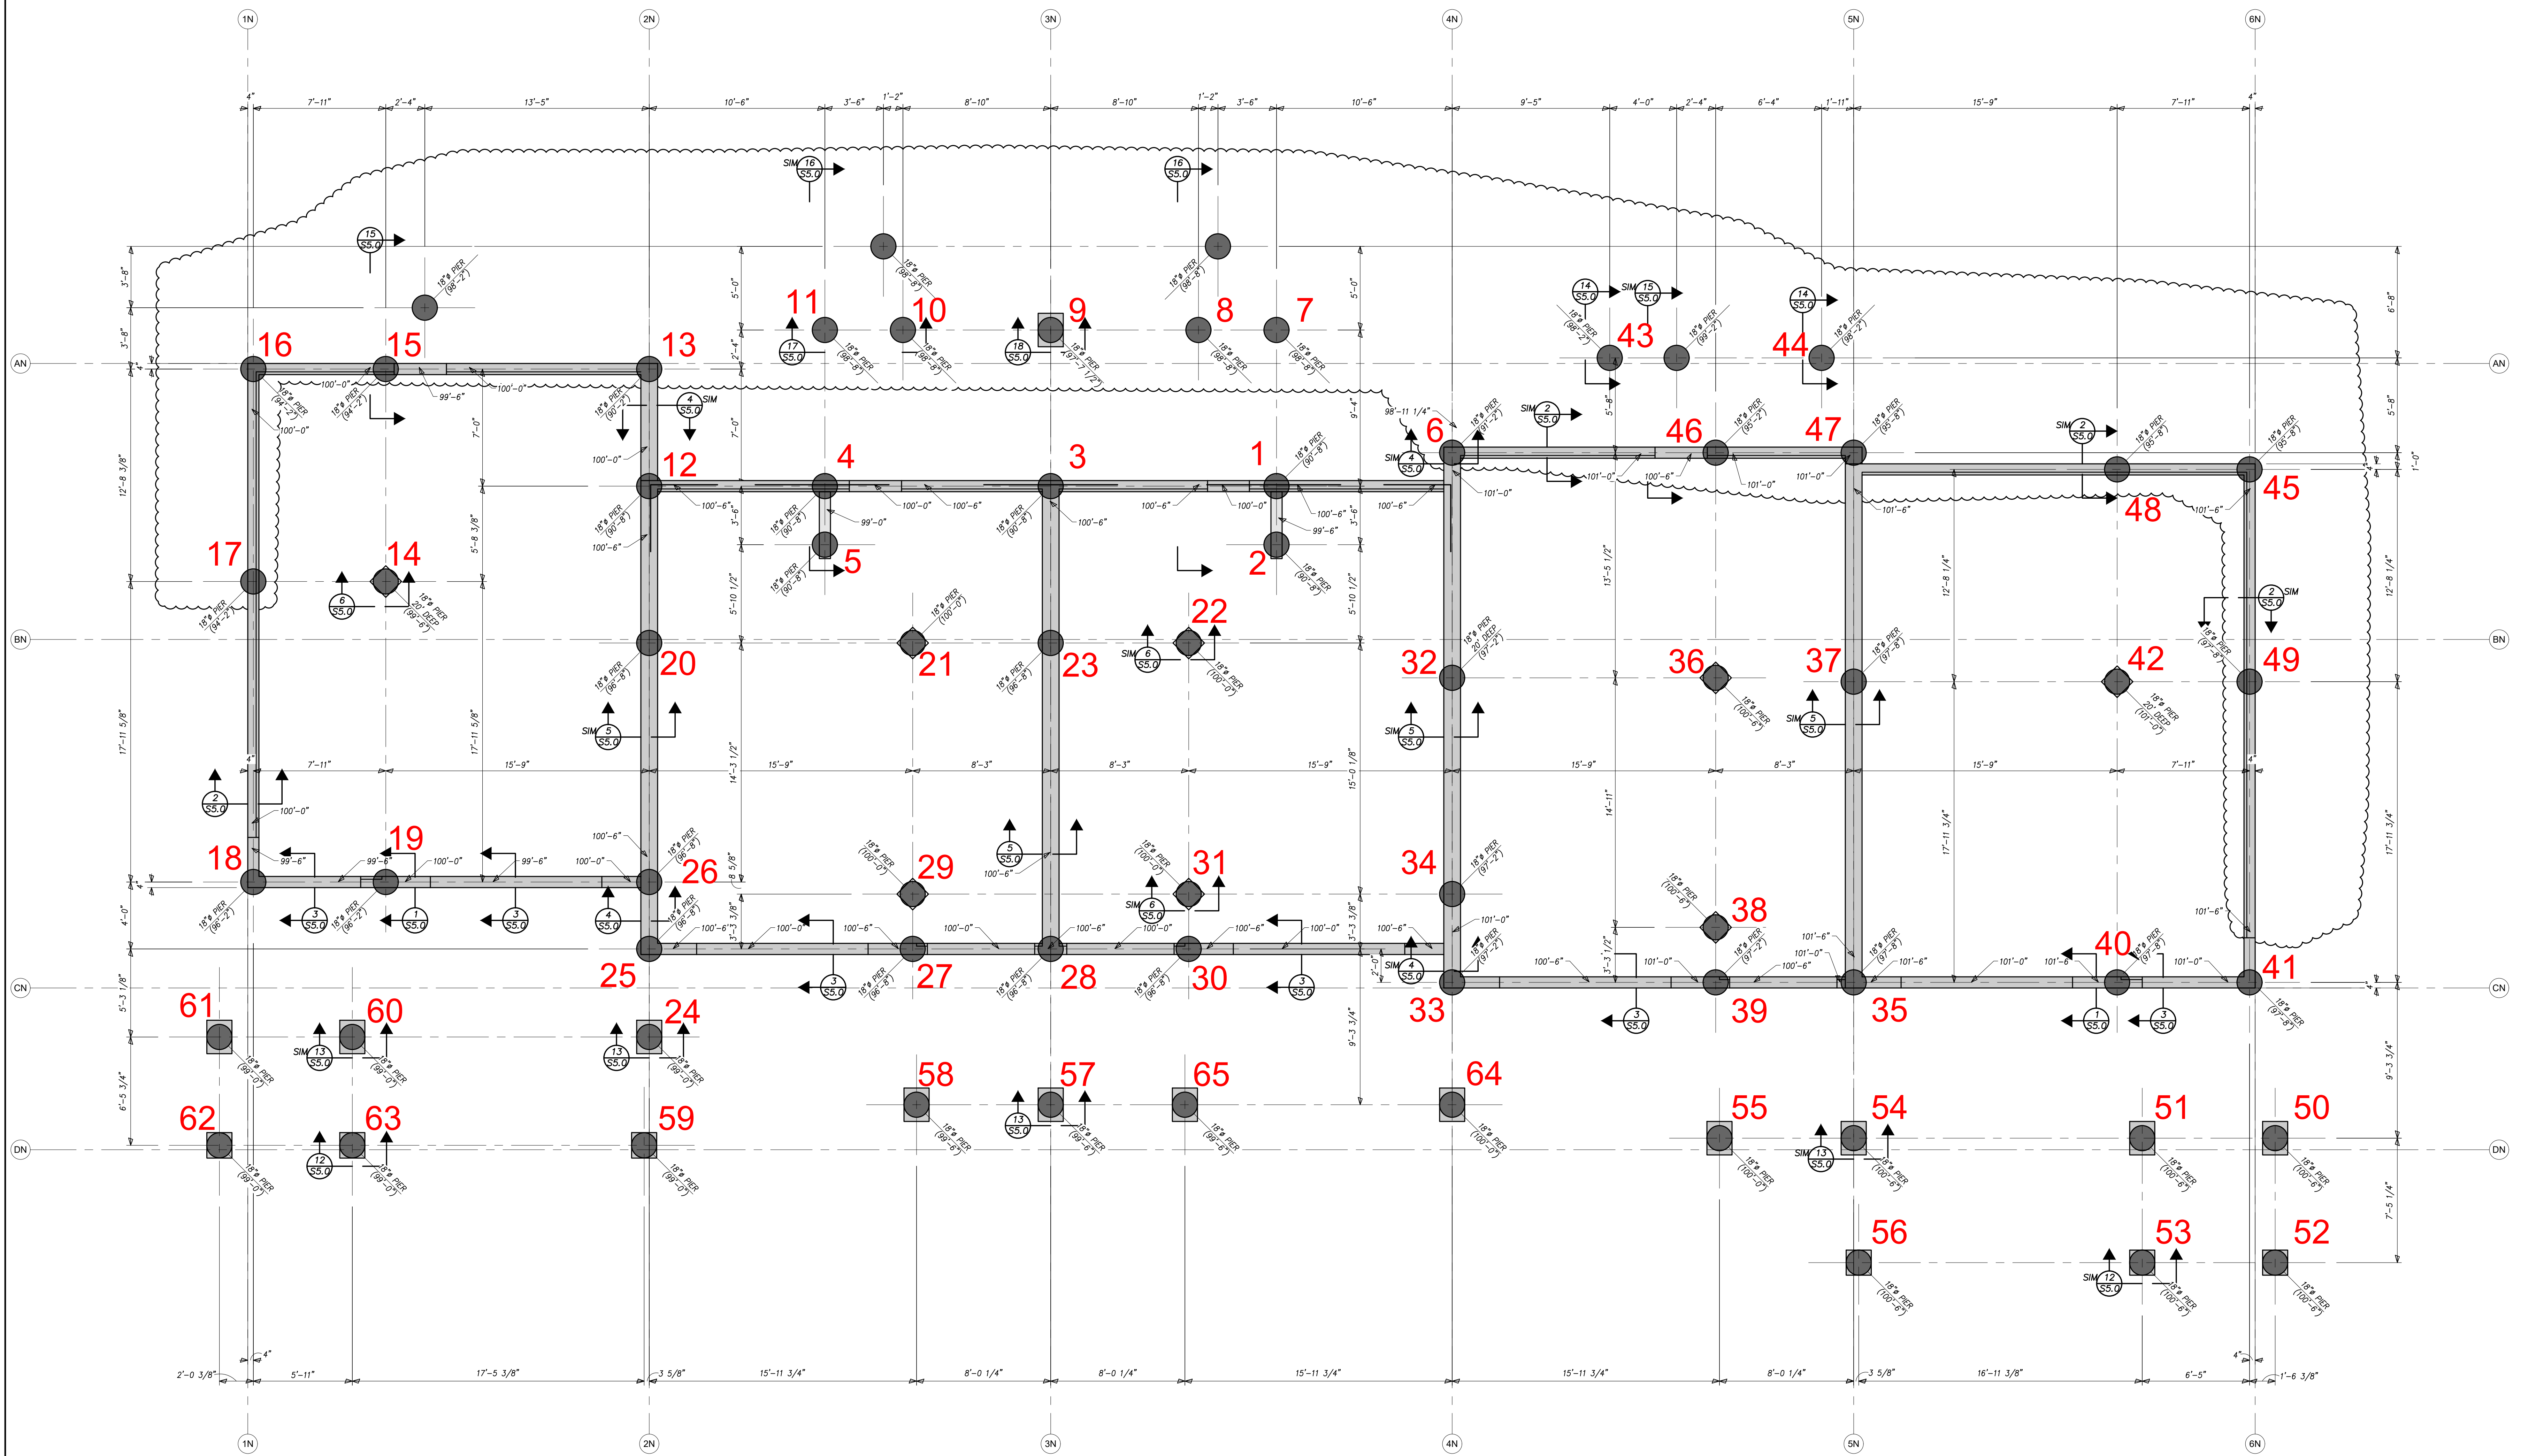
**NORTH BUILDING  
PIER PLACEMENT PLAN**  
 Scale: 1/4" = 1'-0"  
 NORTH  
 ELEVATION TOP OF CONCRETE WALL INDICATED THUS ELEV. →  
 DRILLED PIER LOCATIONS, DIAMETER, AND TOP OF CONCRETE PIER ELEVATION INDICATED THUS ●  
 PIER DIAMETER (ELEVATION)

It should be noted that during the process of concrete placement, pier No. 21 had a blowout at approximately 4-feet below existing grade. Three out of the four sides are surrounded by the on-site soils, but one side is only protected by the sonotube.

The sonotube held in place the top 4 to 4½-feet of concrete meaning there is about 10½ to 11½-feet placed concrete on the on-site soils.

It should also be noted that drilled pier No. 21 should be backfilled with the on-site soils on the side that the on-site soils caved out to minimize water infiltration into the bottom of drilled pier No. 21.

After further discussion on pier No. 21, with Charlie from Alpenglow Engineering Solutions Inc, they decided that pier No. 21 is good and there is no need to drill another pier next to it.

It should be noted that NWCC informed Sean with INC8 and Rob with Colorado Home Solutions that pier No. 21 needed to be backfilled with the on-site soils and not granular material.

As requested, we visited the project site on today's date upon completion of backfill compaction with the on-site clays and gravels materials for pier No.'s 21 & 23 on the west side of the piers, in 1-foot lifts with a jumping jack until reaching subgrade grade. INC8 completed the filling as requested by NWCC. The observations did meet our backfill request.
