**RE: SPK-2007-1323 – The Astrid – Pre-Construction Notification**

# THE ASTRID

## SPK-2007-1323

### PRE-CONSTRUCTION NOTIFICATION

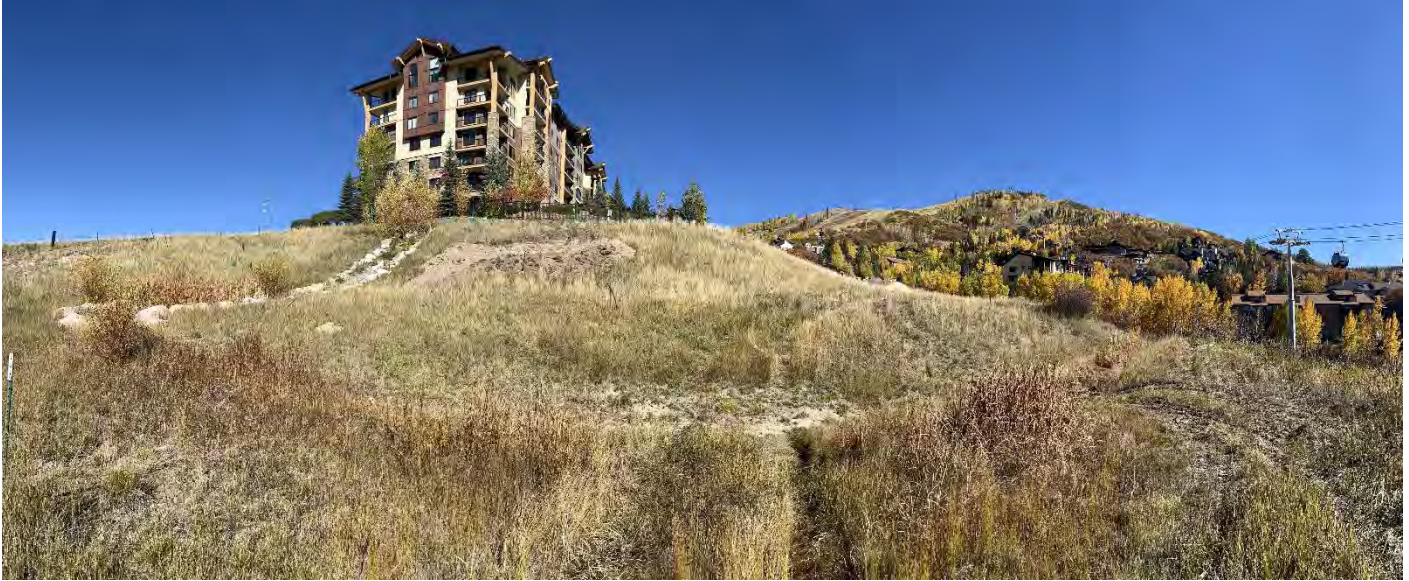
Photograph from drainage bottom facing uphill towards Edgemont Condominium and Plot 5, which is located in the rock-lined foundation drain outfall visible starting from Edgemont and traveling downhill.

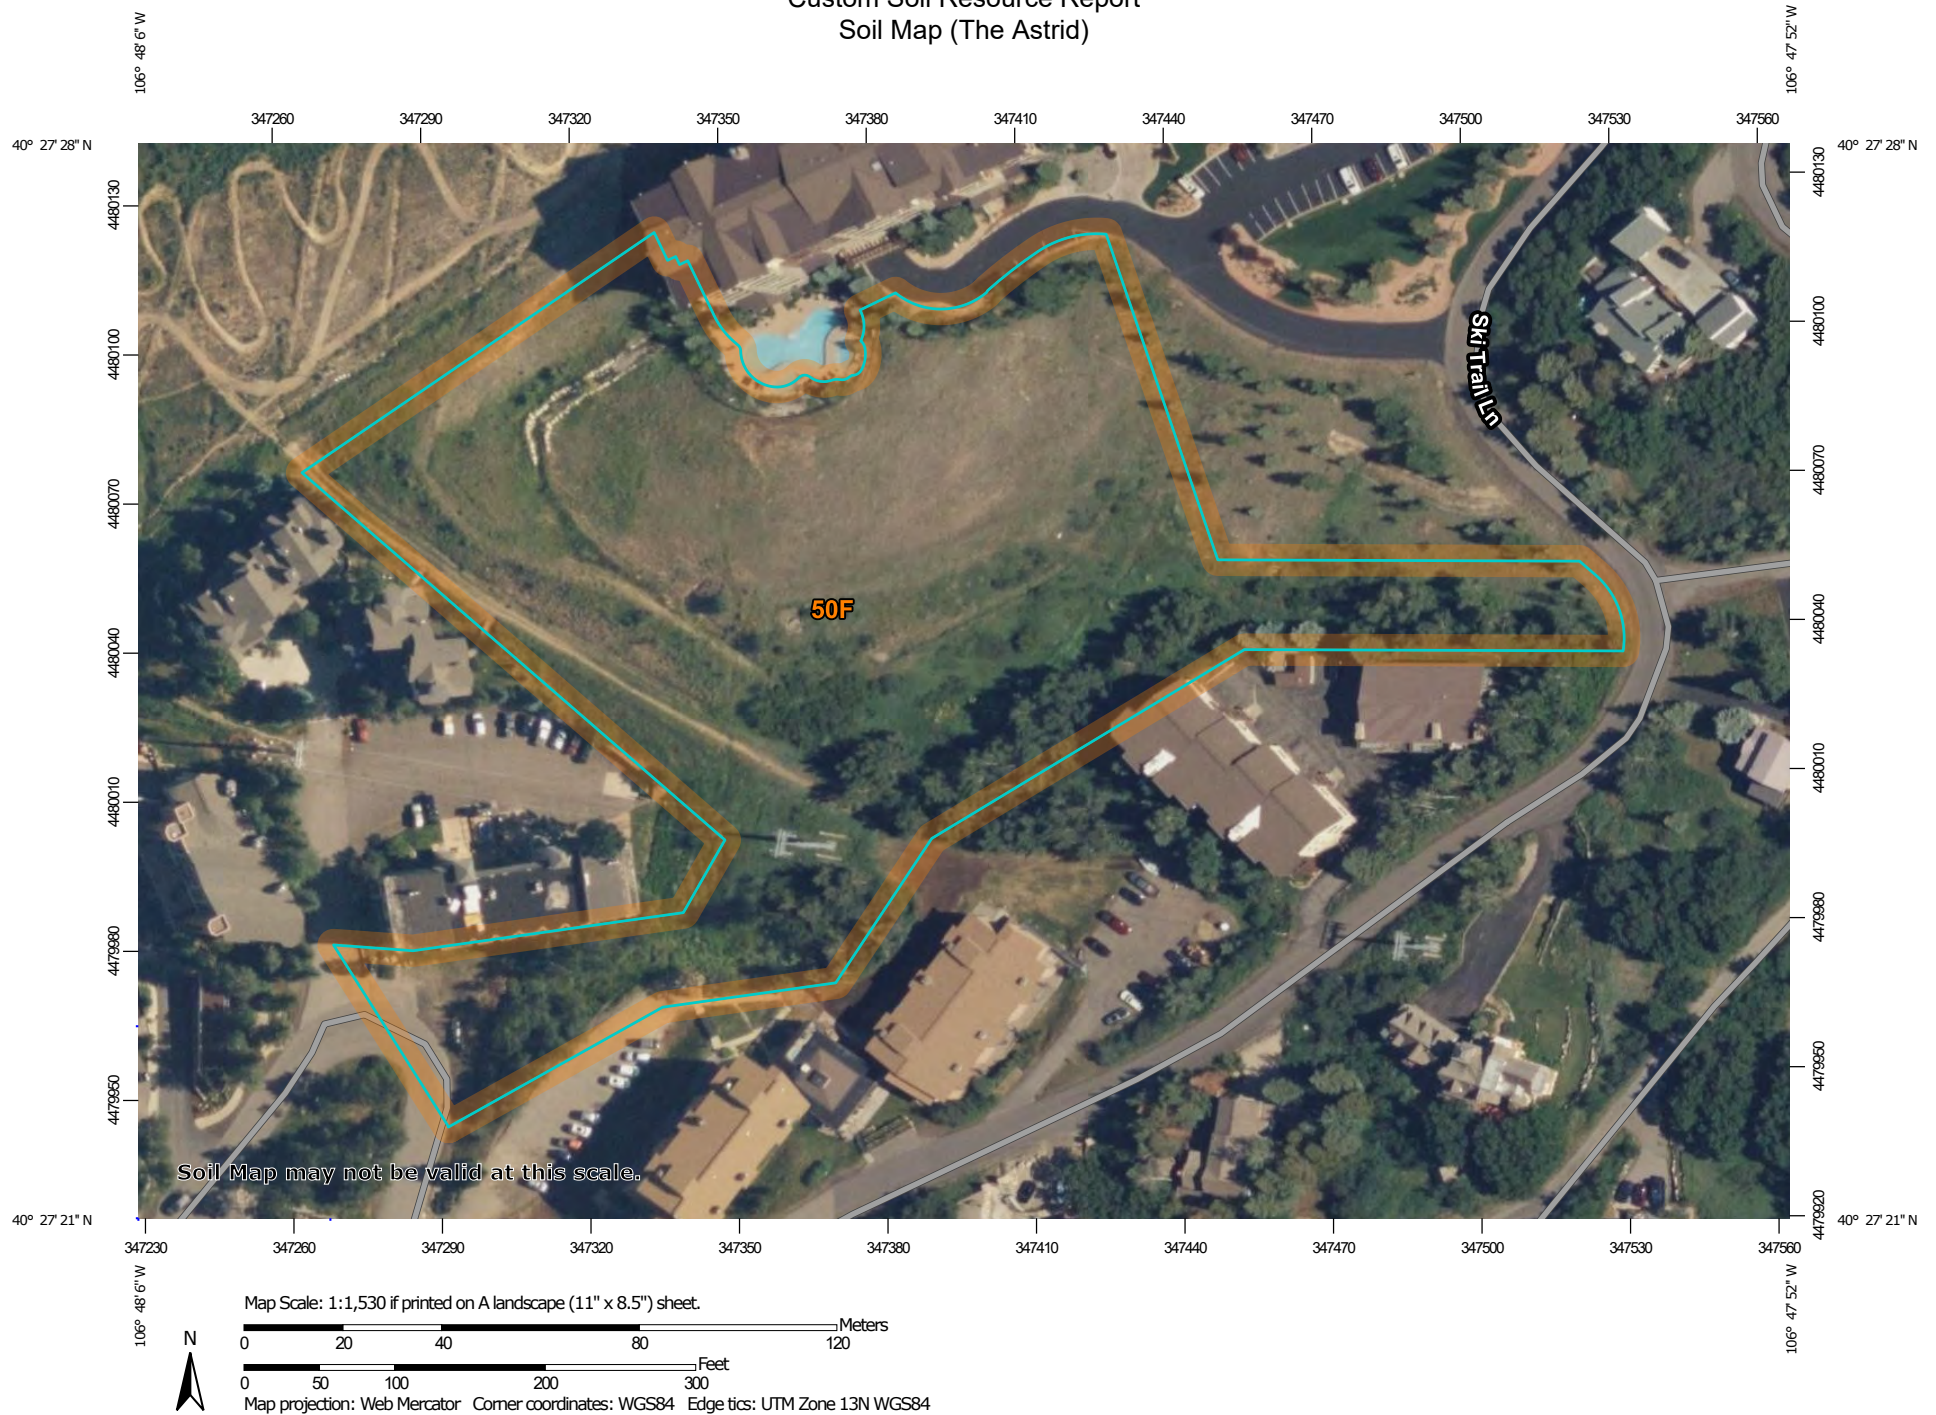
# Custom Soil Resource Report Soil Map (The Astrid)

The soil map section includes the soil map for the defined area of interest, a list of soil map units on the map and extent of each map unit, and cartographic symbols displayed on the map. Also presented are various metadata about data used to produce the map, and a description of each soil map unit.

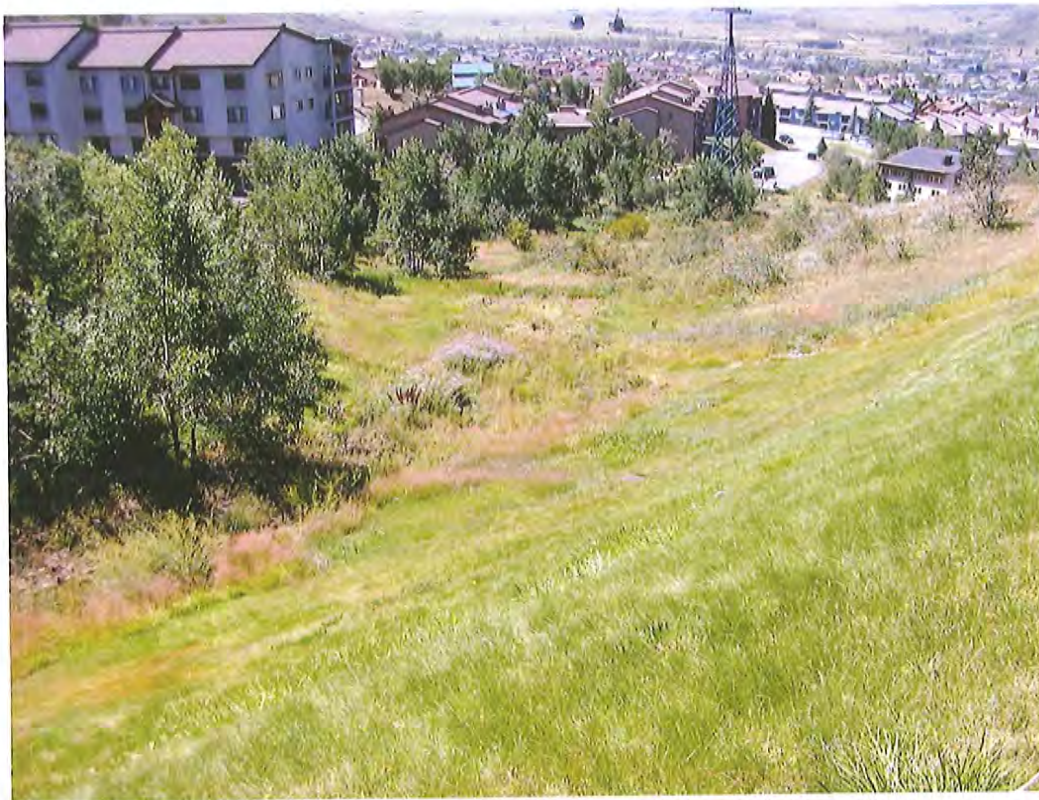
**Photo 1.** Overview of the Outlot and Lower Swale Wetland from the lawn of the existing Bear Claw Condominiums, view to the southwest. (8/10/06).

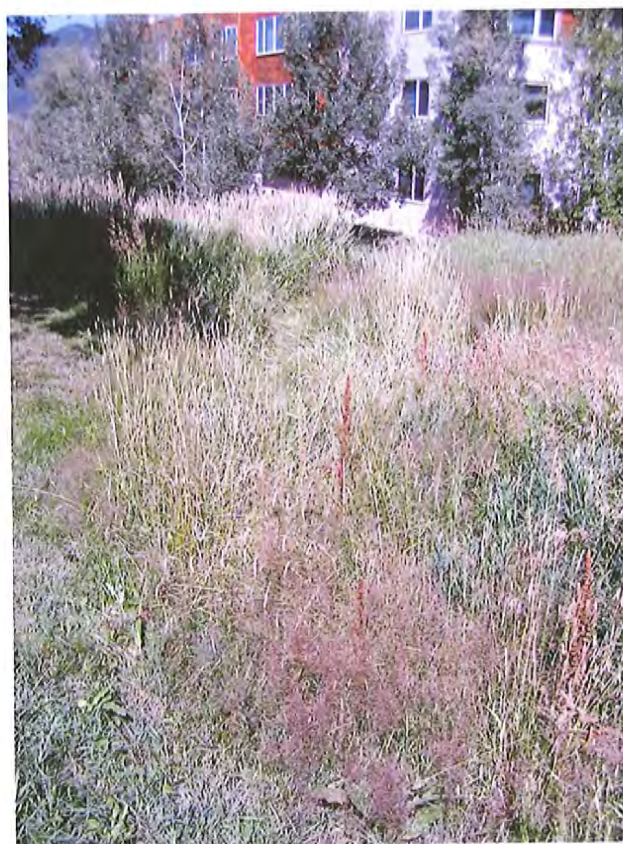
**Photo 2.** The Lower Swale Wetland is dominated by reed canarygrass and redtop, introduced grasses. (8/10/06).

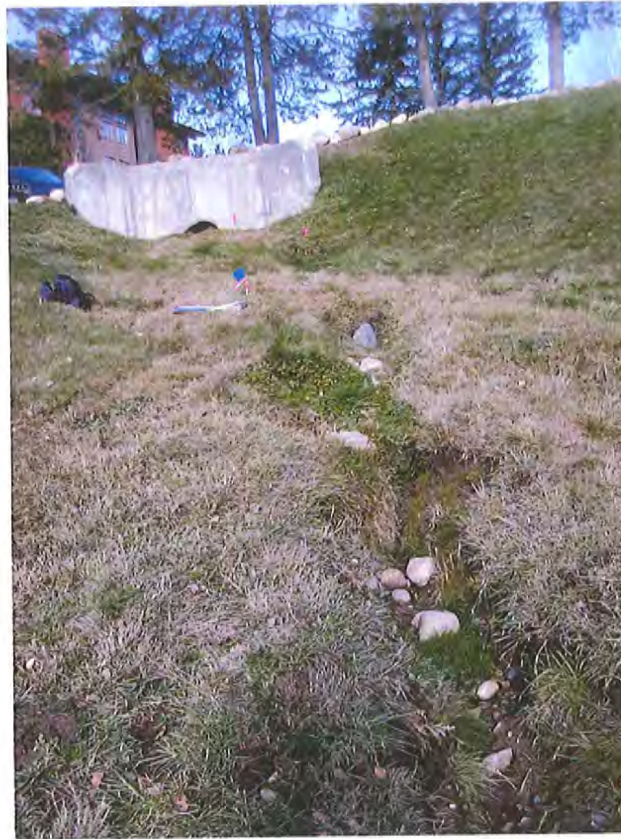
**Photo 3.** Ditch in the Upper Swale Wetland. (11/3/06).

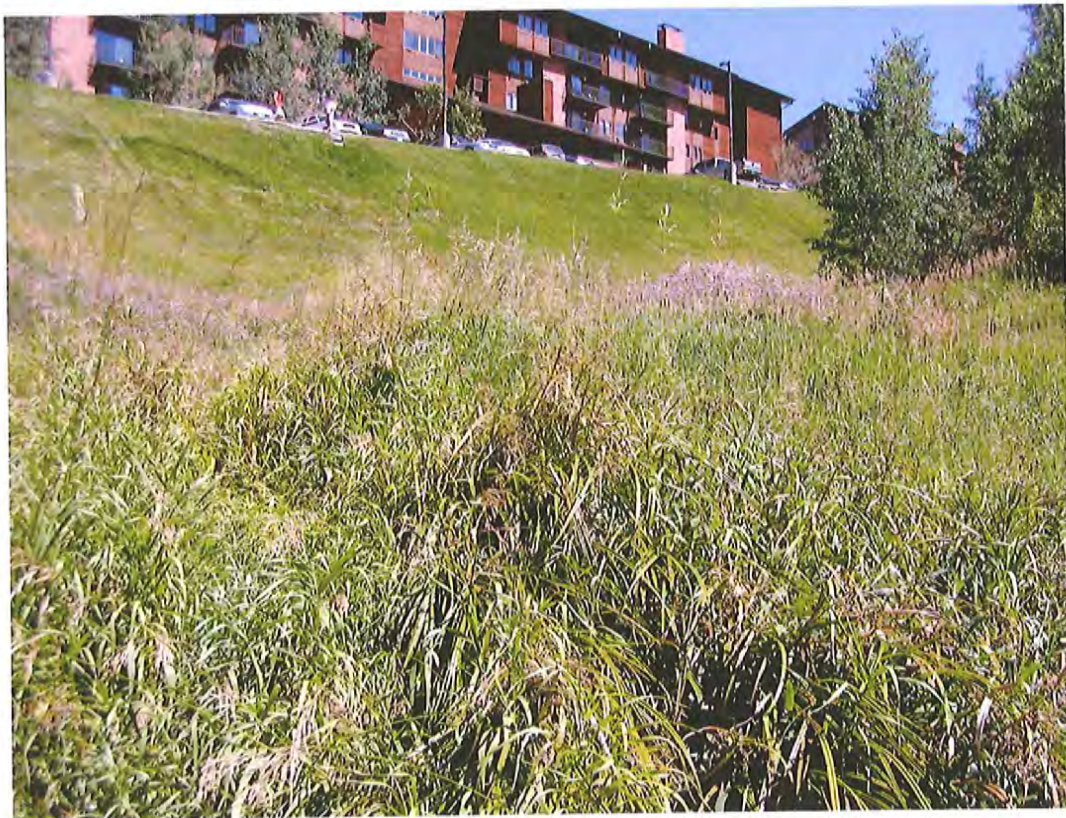
**Photo 4.** Stands of cloaked bulrush and reed canarygrass are common near the lower end of the Upper Swale Wetland. (8/10/06).

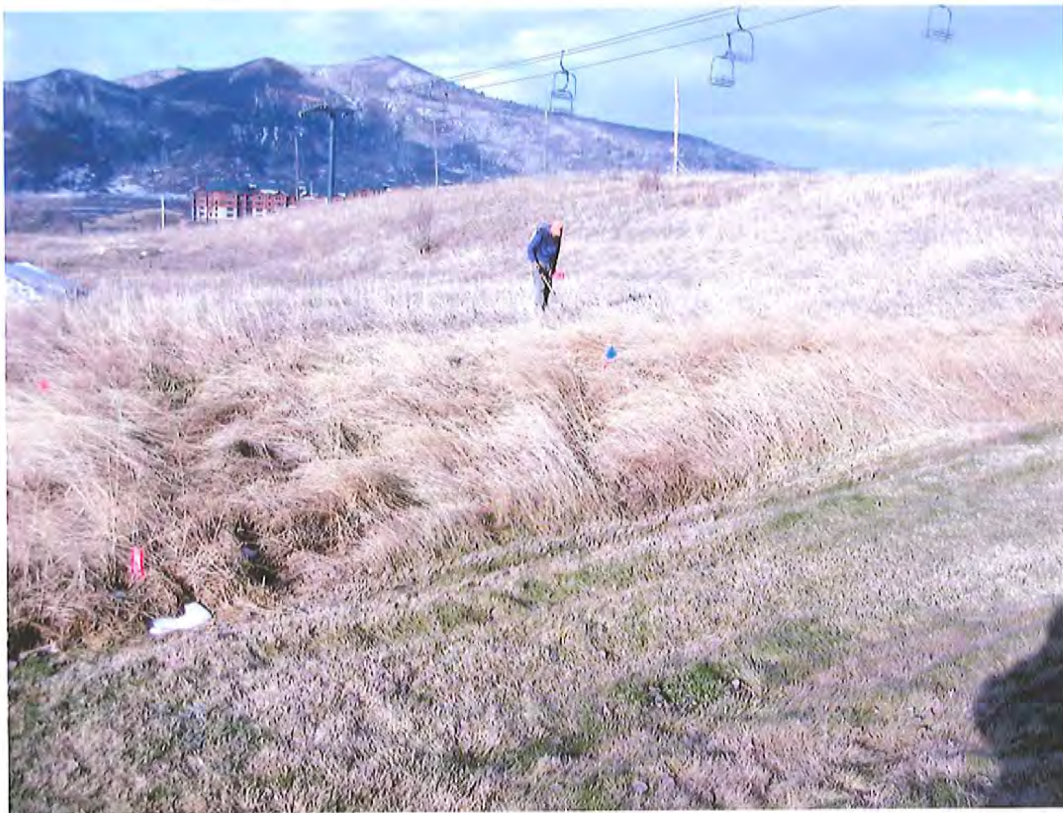
**Photo 5.** Wetland A is supported by irrigation runoff from the lawn in the foreground that pools in a shallow depression. (11/3/06).

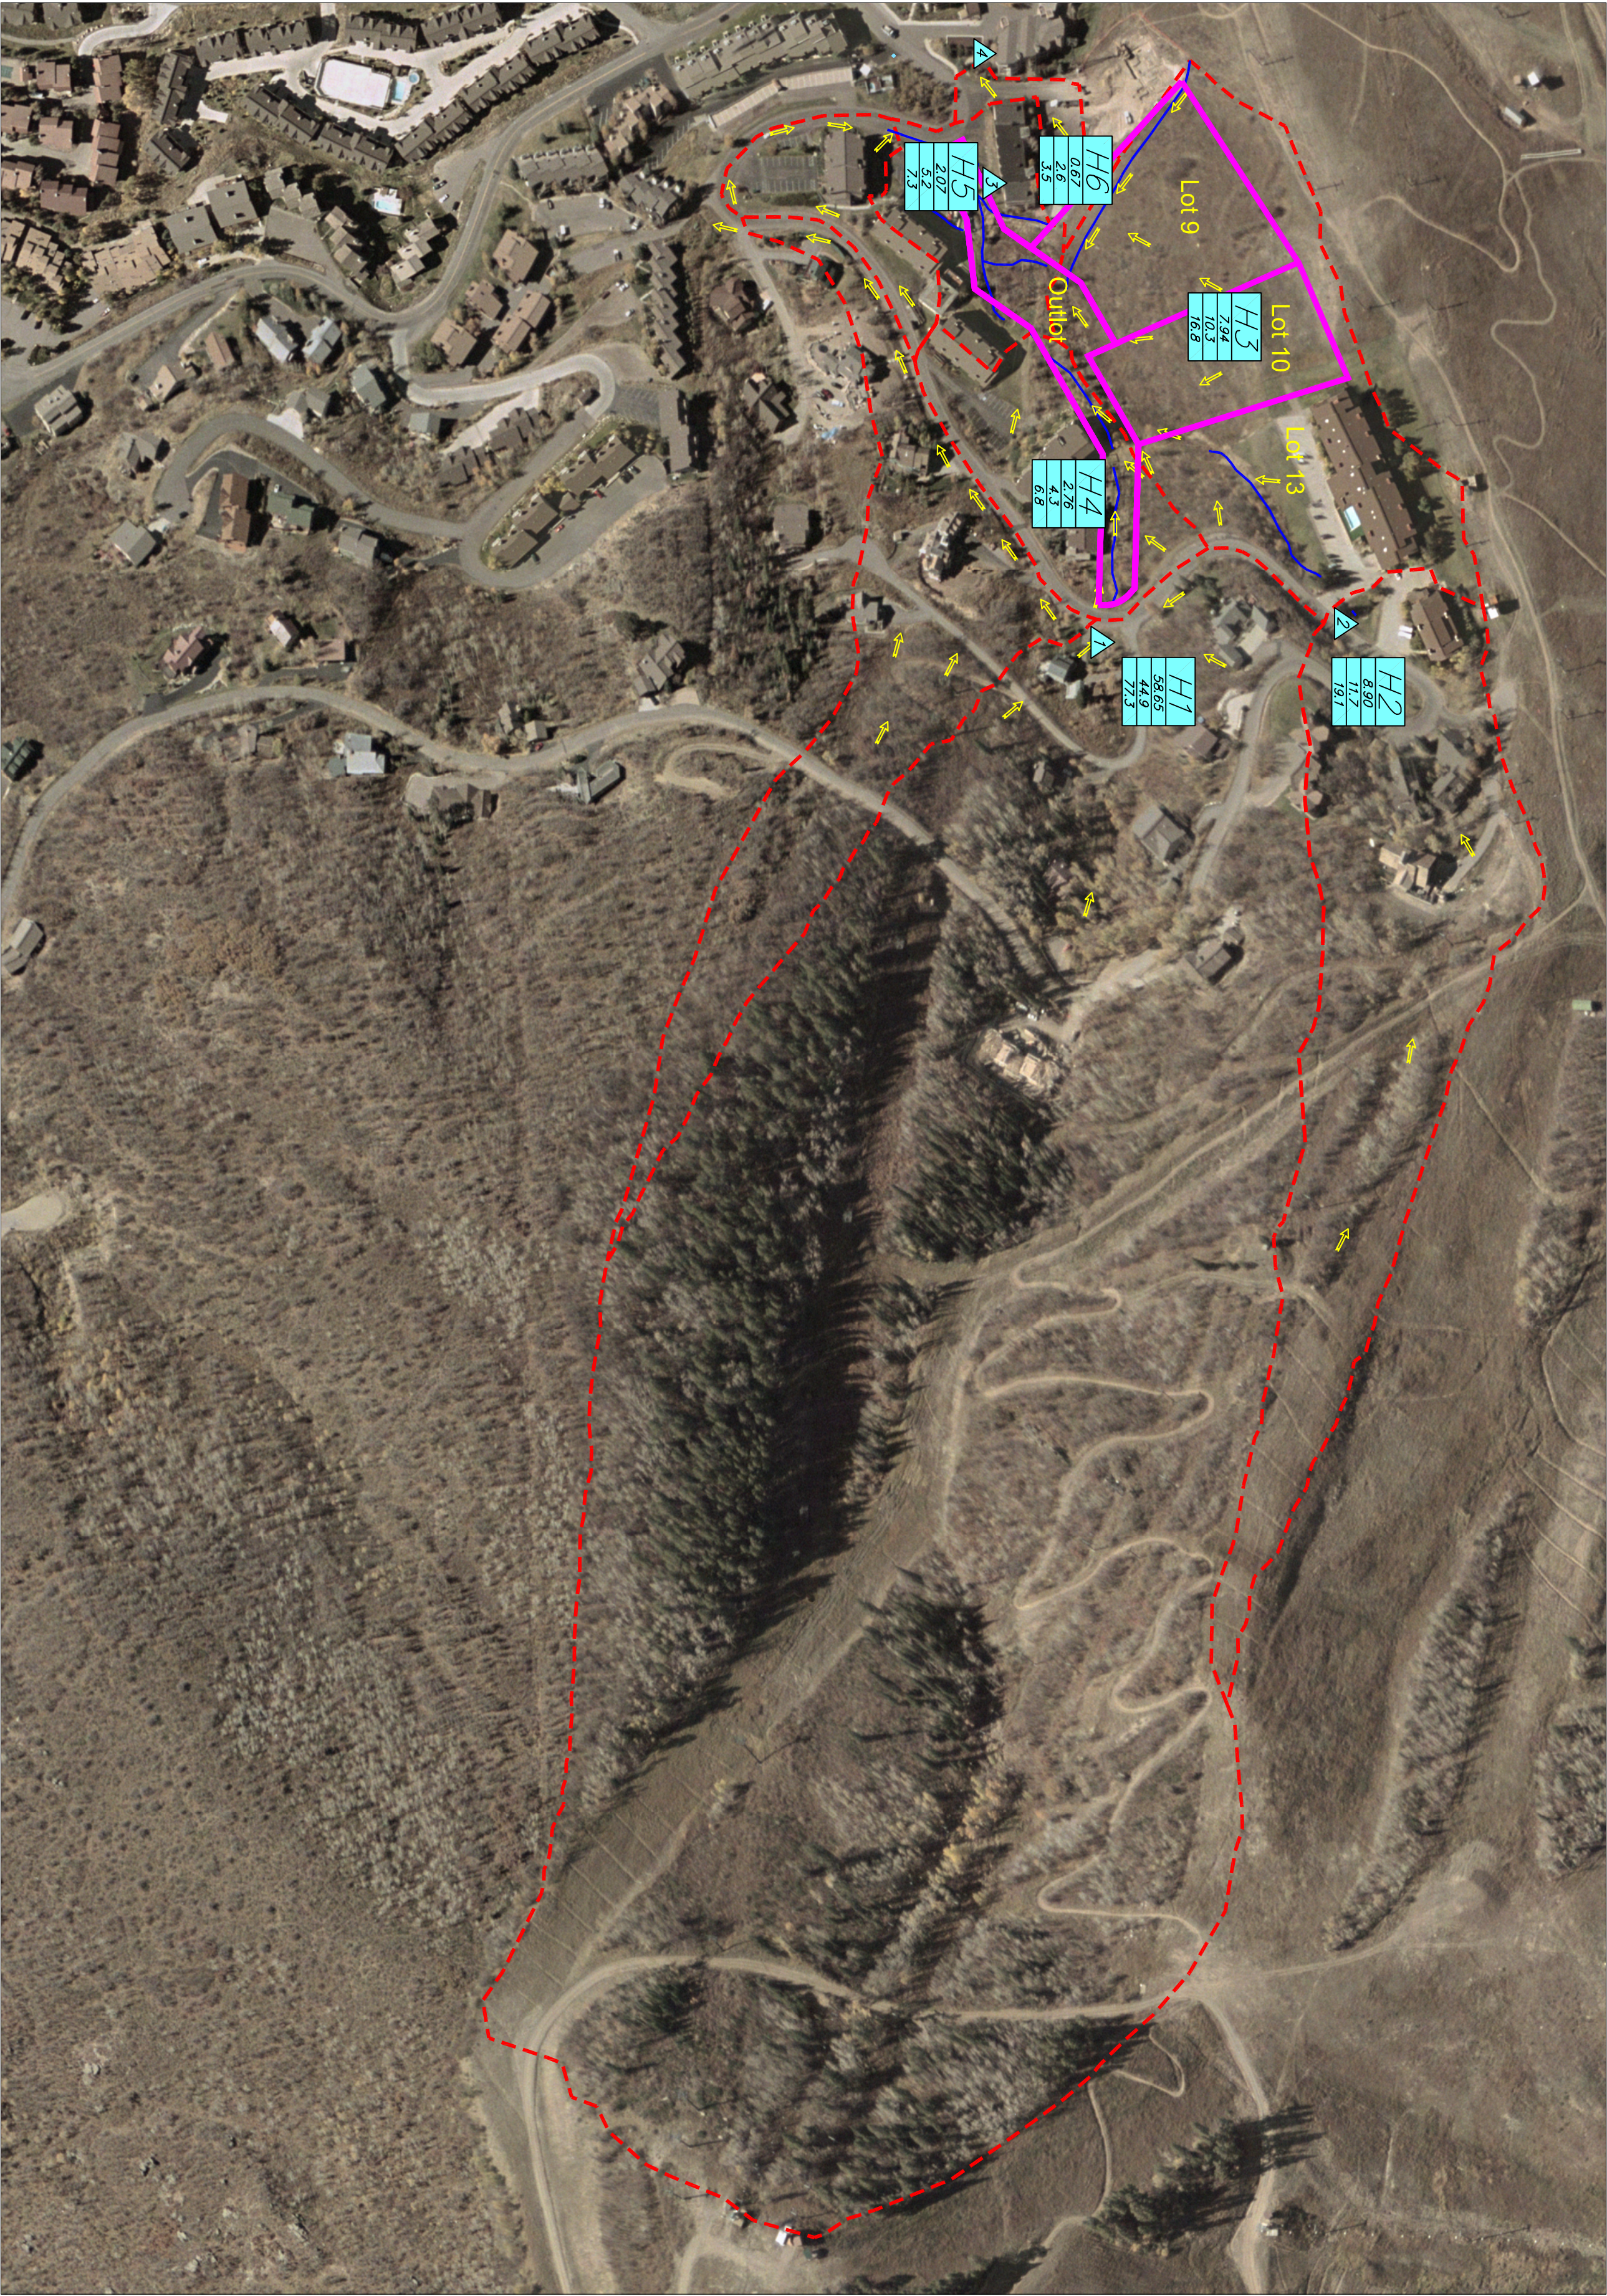
Figure 4.  
Project Site Drainage Basin

The project site includes 5.30 acres of an 81 acre drainage basin. As illustrated by Figure 4, most of the drainage basin is undeveloped and consists of ski trails dominated by herbaceous vegetation and adjacent forested areas. There is an unvegetated gravel road.

- Watershed Size – 5.30 acres of an 81 acre watershed (See Figure 4)
- Drainage Area – 5.30 acres of an 81 acre drainage basin
- Average Annual Rainfall – 23.4 inches
- Average Annual Snowfall – 165.0 inches

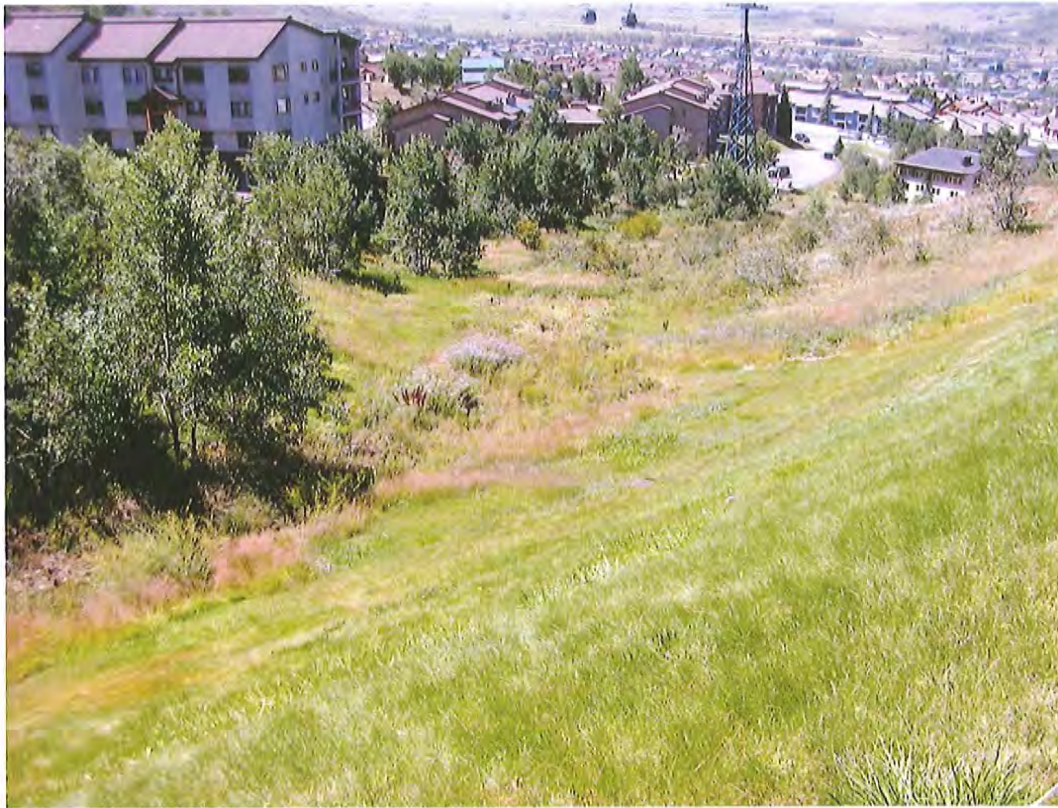
**Photo 1.** Overview of the ephemeral drainage and outlot from the lawn of the existing Bear Claw Condominiums, view to the southwest. (8/10/06).

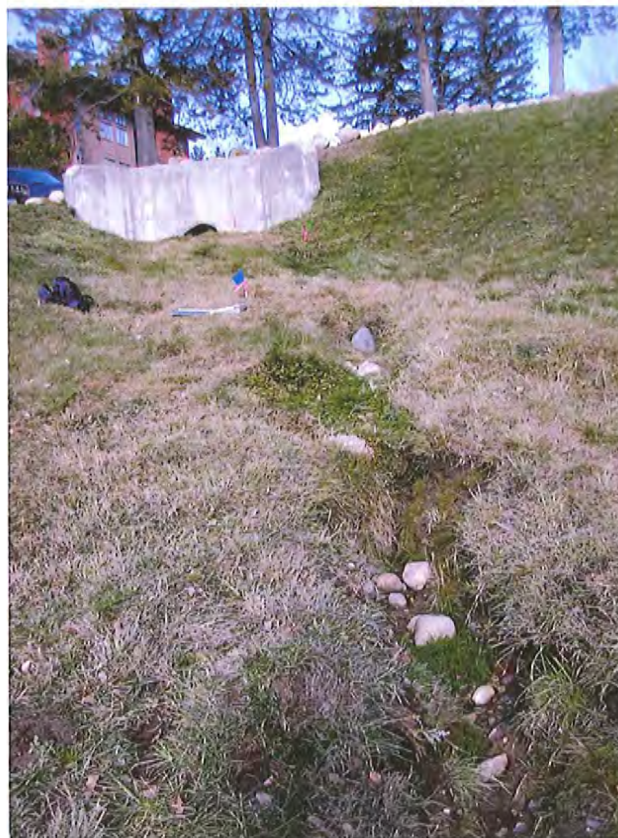
**Photo 2.** Ground water discharge area just below the sewer line crossing in the Upper Ephemeral Drainage Wetland. (11/3/06).

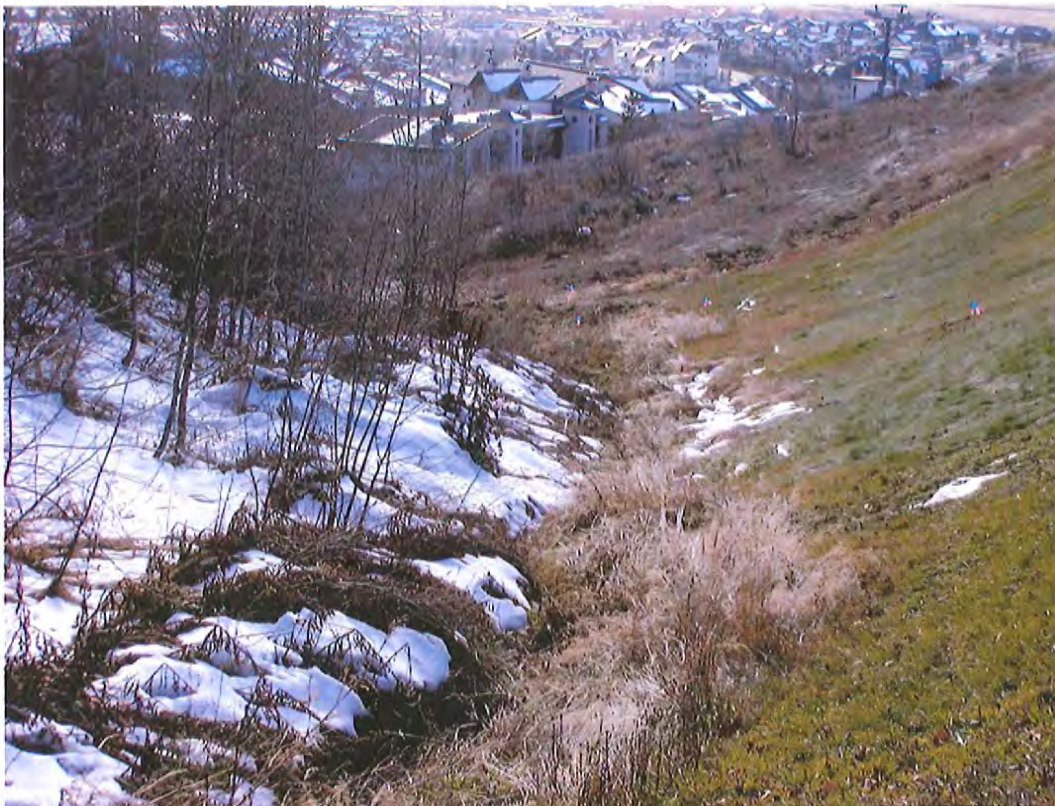
**Photo 3.** View of the Upper Ephemeral Drainage Wetland during the delineation in November. (11/3/06).

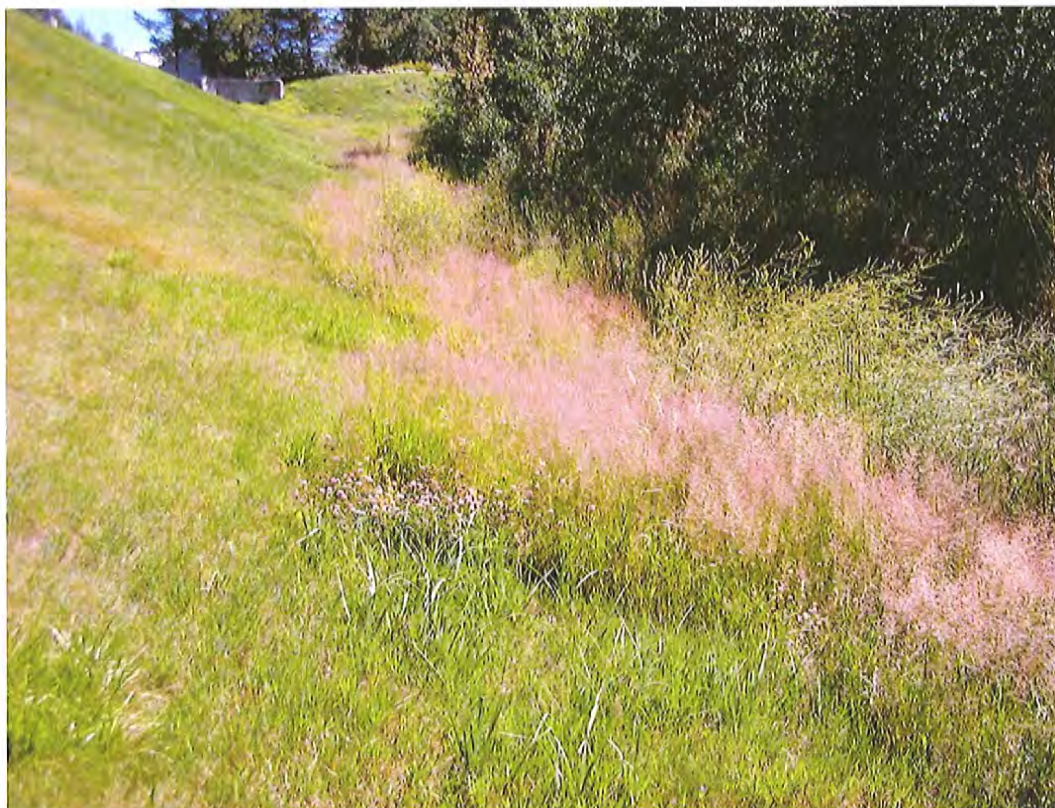
**Photo 4.** Redtop, water sedge, and red fescue are common in the Upper Ephemeral Drainage Wetland at the base of the irrigated lawn. (8/10/06).

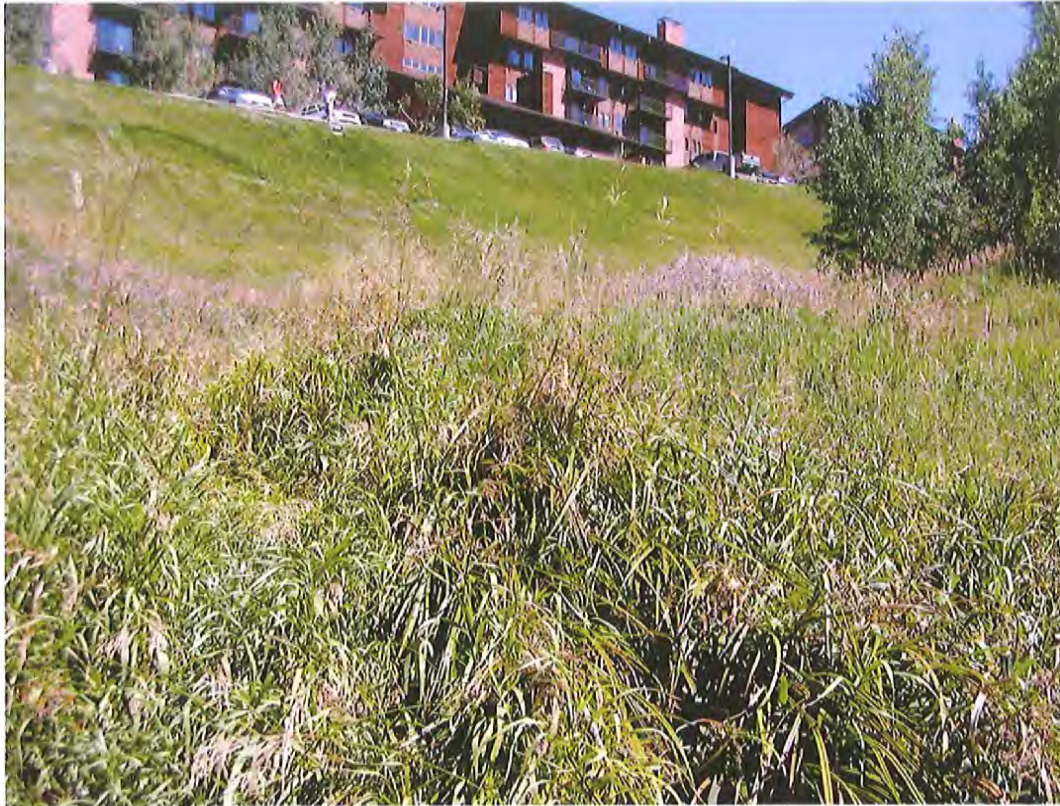
**Photo 5.** Stands of cloaked bulrush and reed canarygrass are common near the lower end of the Upper Ephemeral Drainage Wetland. (8/10/06).

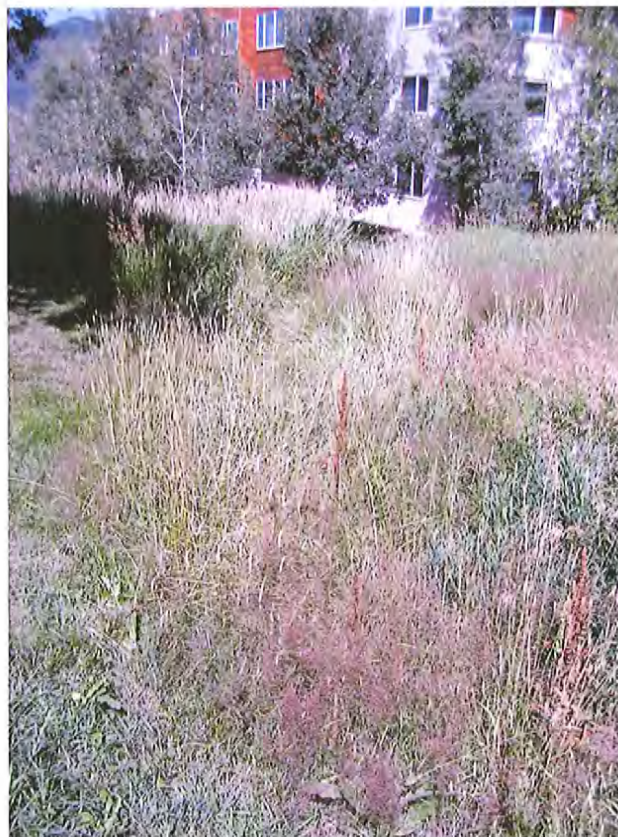
**Photo 6.** The Lower Ephemeral Drainage Wetland is dominated by reed canarygrass and redtop. (8/10/06).

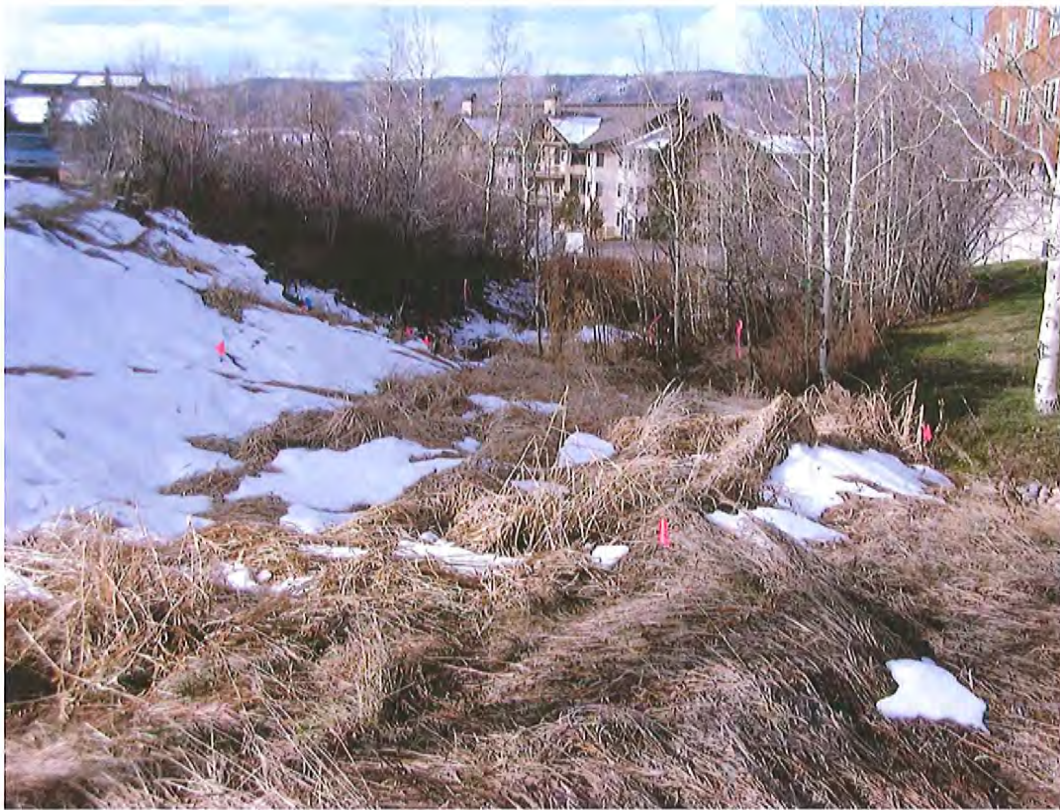
**Photo 7.** Lower Ephemeral Drainage Wetland, view to the west. (11/3/06).

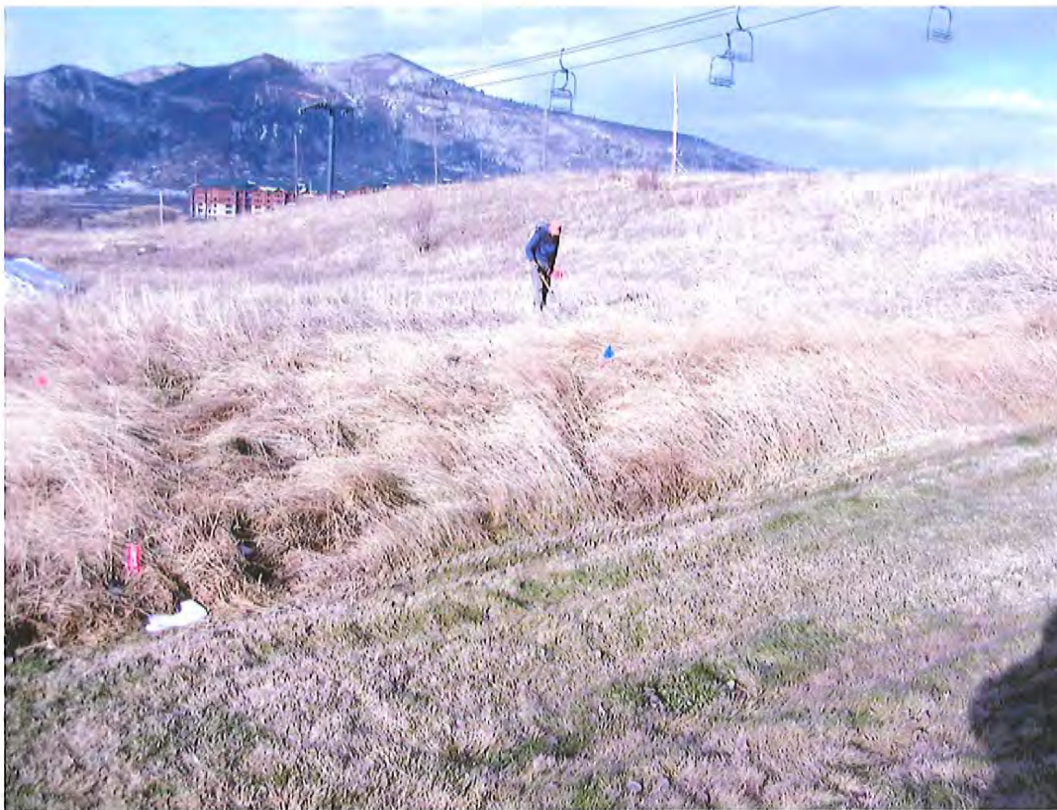
**Photo 8.** Wetland A is supported by irrigation runoff from the lawn in the foreground that pools in a shallow depression. (11/3/06).
