Job Number: 19-11550

Subject: Geotechnical Investigation,
Greenhorn Ranch/Wildblue, New Boulevard
Road, Steamboat Ski Resort, Routt County,
Colorado.

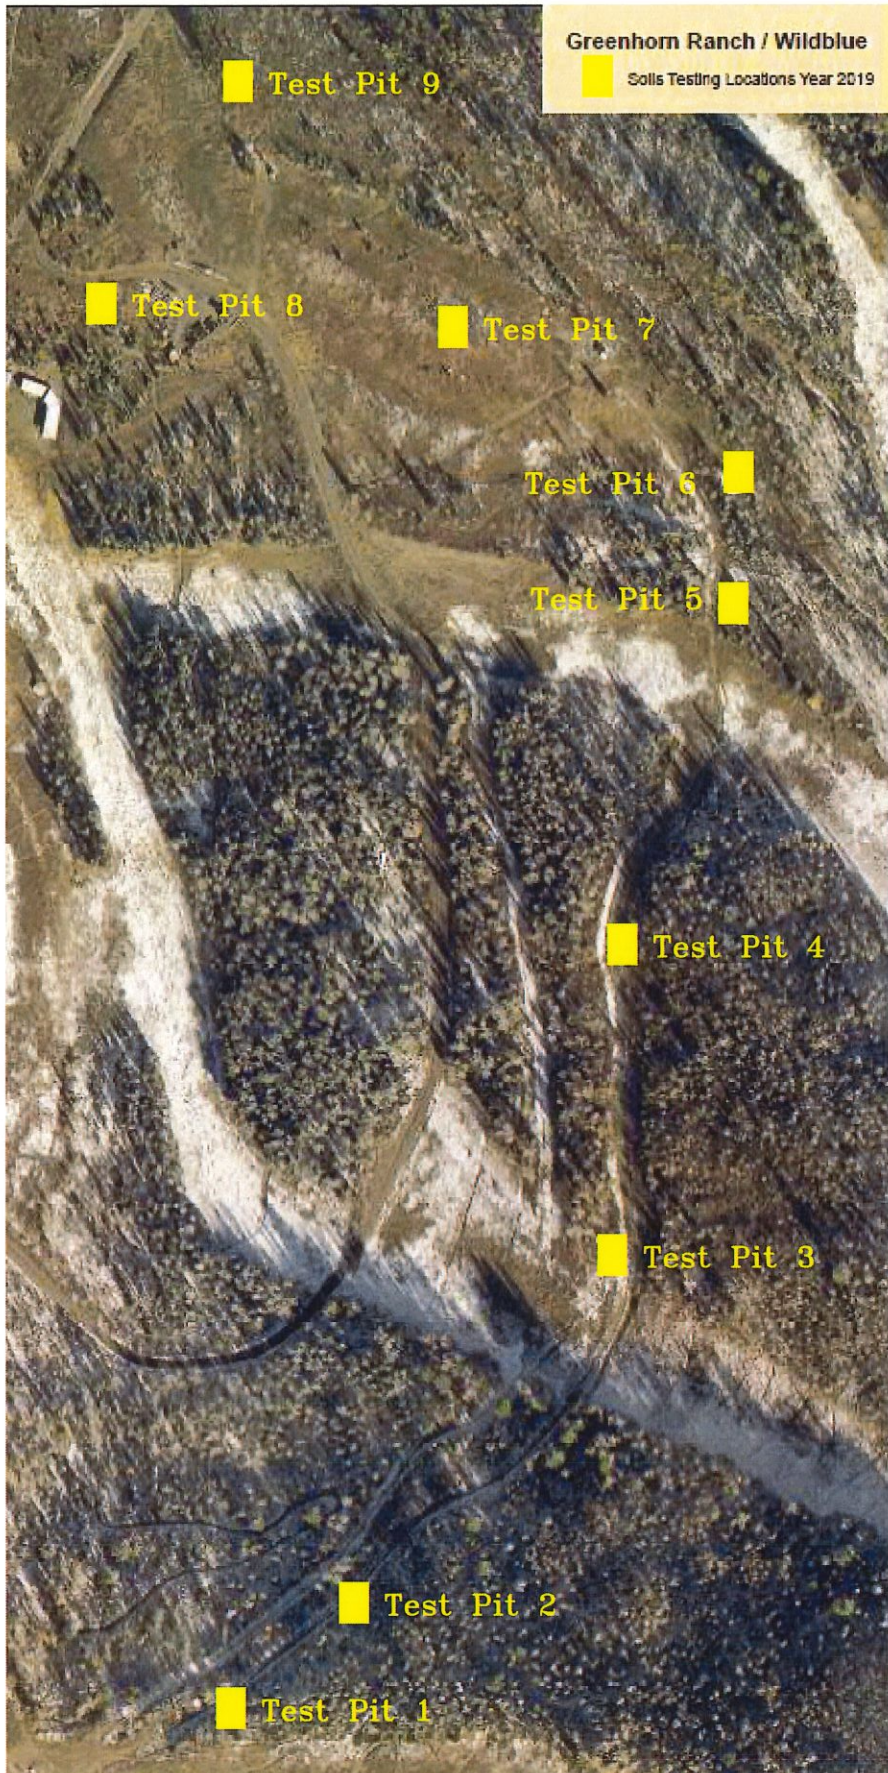
Figure #2

Title: SITE PLAN-LOCATION OF TEST PITS

Job Name: Greenhorn Ranch/Wildblue-New Boulevard Road

Subsurface Conditions: To investigate subsurface conditions, nine (9) test pits were advanced at the site on October 8, 2019 with a CAT 336F trackhoe provided by the client. A site plan showing approximate test pit locations is presented in Figure #2.

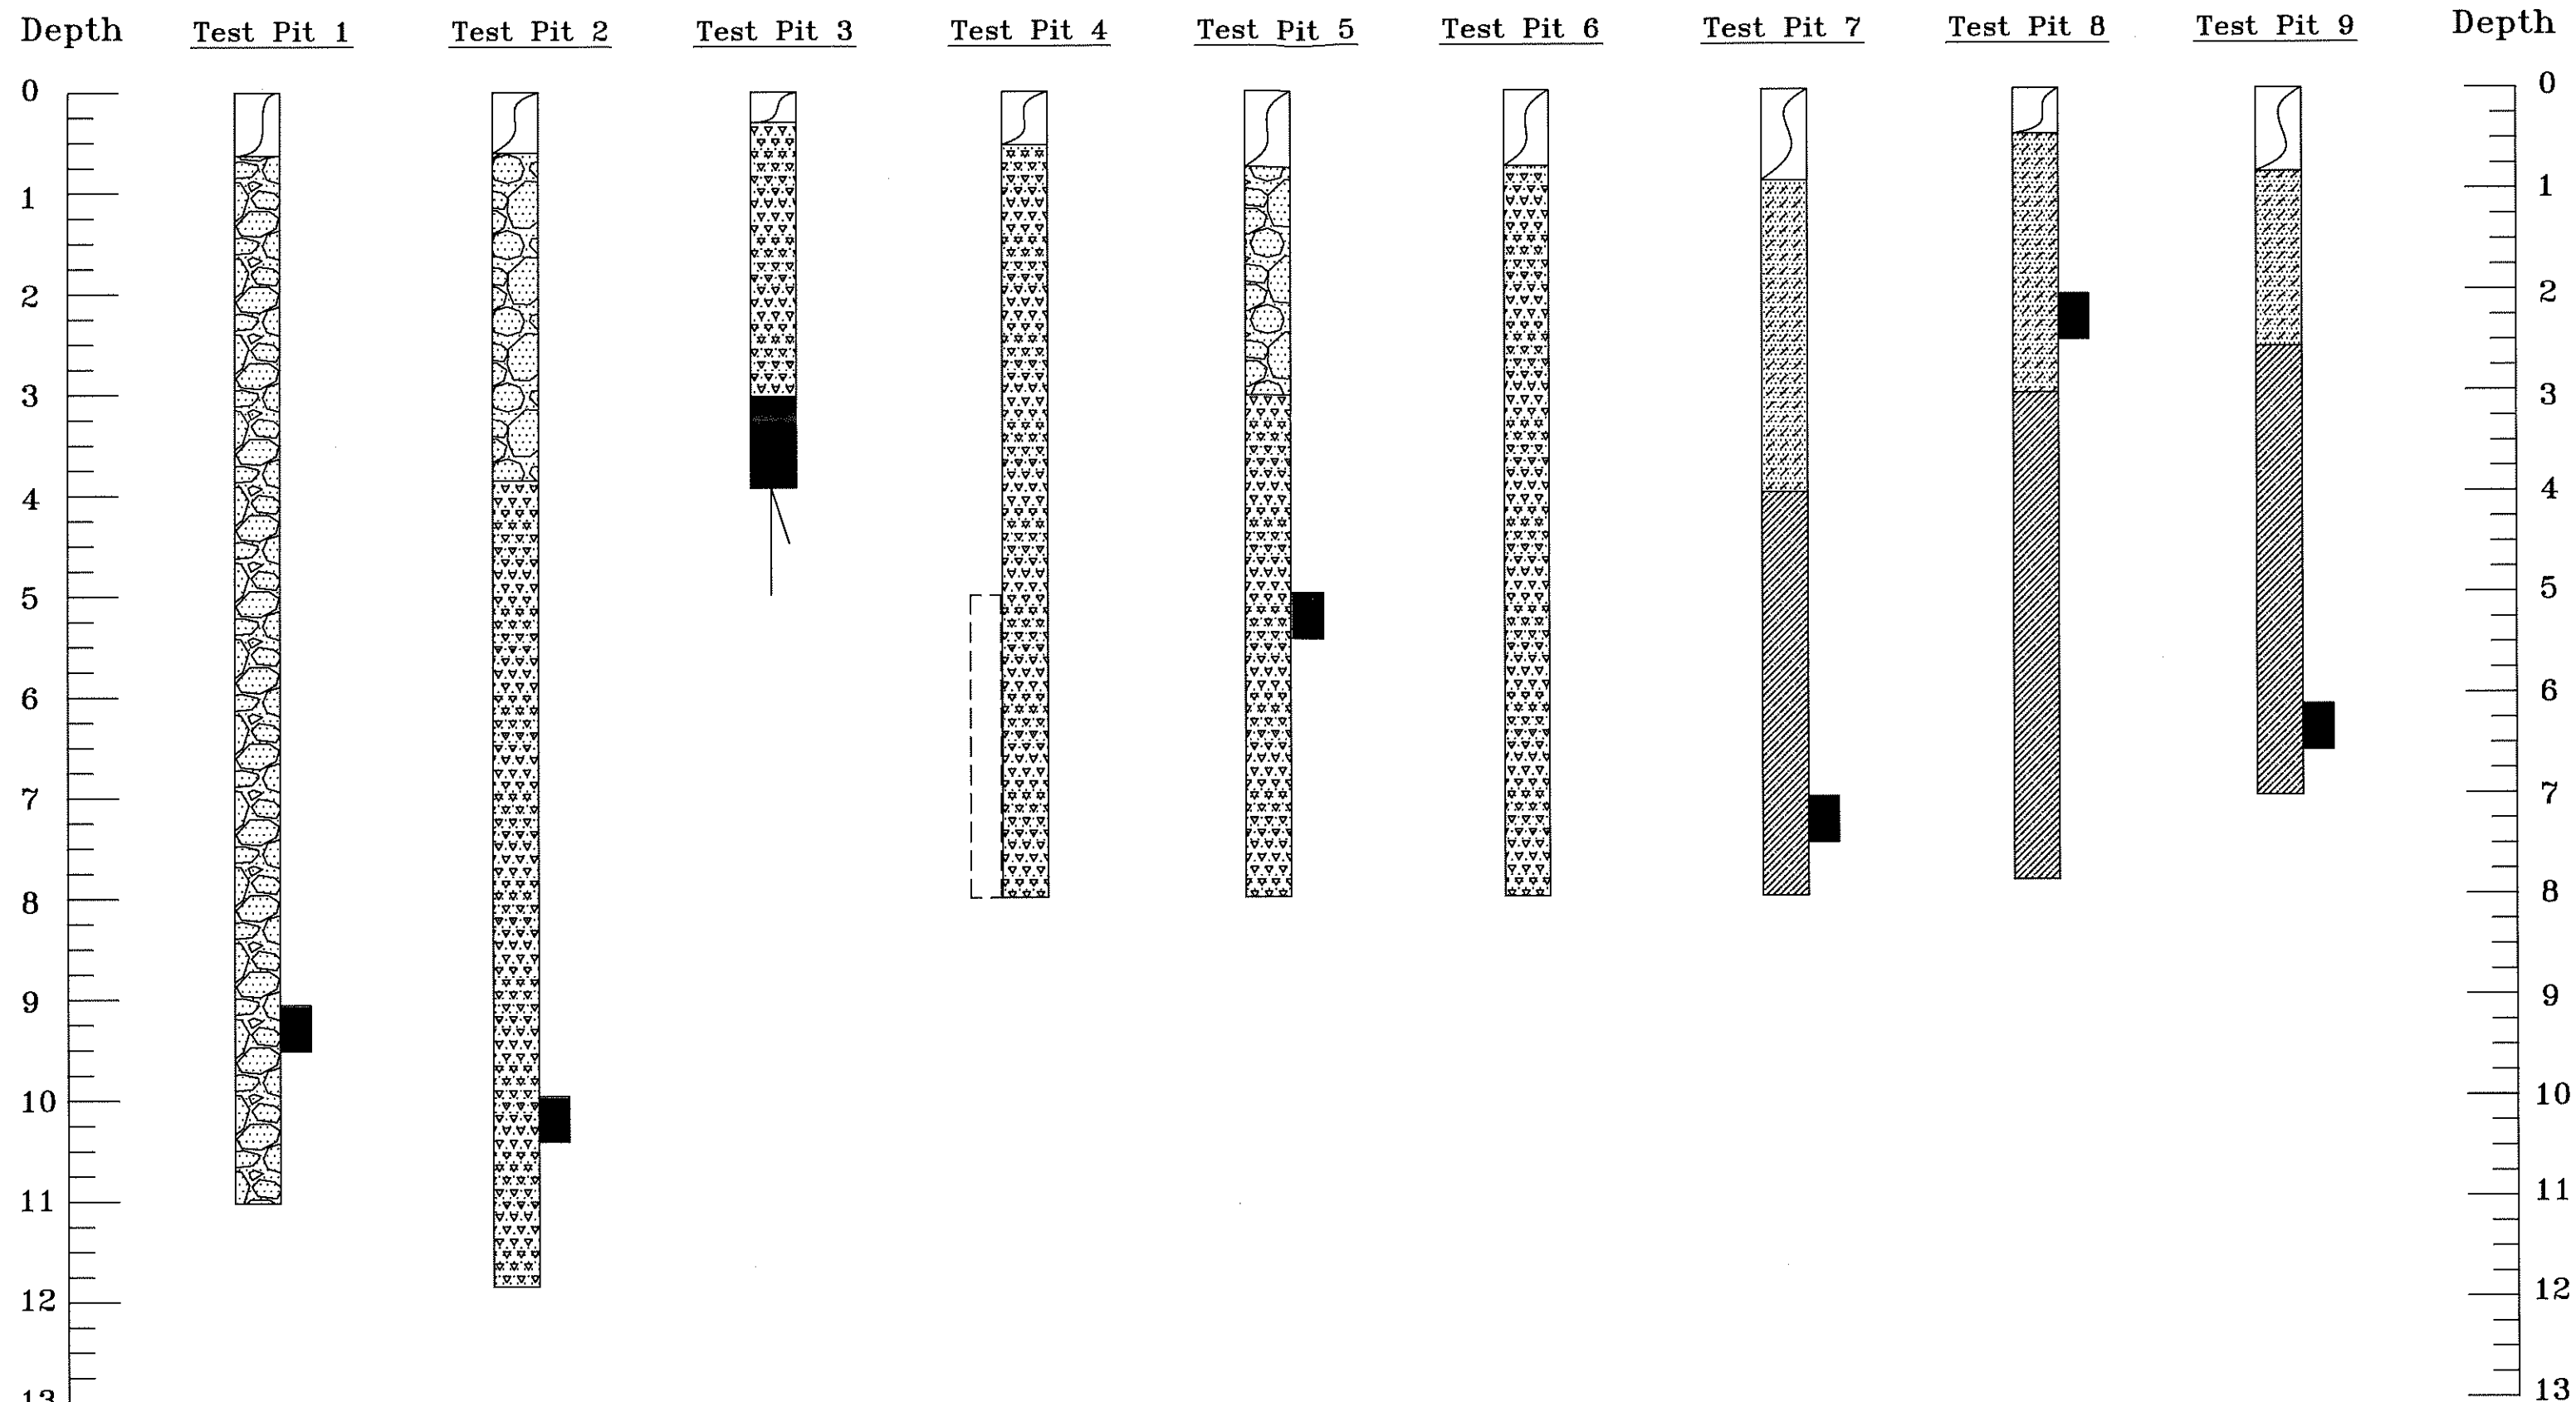
NWCC North West Colorado Consultants, Inc. Geotechnical / Environmental Engineering / Materials Testing (970)879-7888 Fax (970)879-7891 2580 Copper Ridge Drive Steamboat Springs, Colorado 80487	Title: Logs of Exploratory Test Pits		
	Job Name: Greenhorn Ranch/ The Wild Blue		
	Location: New Boulevard Road, Steamboat Ski Resort, Steamboat Springs, CO		
	Job No.: 19-11550	Date: 1/13/20	Fig. # 3

Subsurface conditions encountered in the test pits were variable and generally consisted of a layer of natural topsoil and organic materials overlying natural sands and gravels, clays and sands and decomposed granite overlying crystalline or sandstone bedrock. The maximum depth excavated was 12 feet beneath the existing ground surface (bgs). Graphic logs of the exploratory test pits are presented in Figure #3, and associated Legend and Notes are presented in Figure #4.

A layer of natural topsoil and organic materials, approximately 4 to 10 inches in thickness, was encountered at the ground surface in all test pits. Sands and gravels were encountered beneath the topsoil and organic materials in Test Pits 1, 2 and 5, extending to depths ranging from 3 to 11 feet bgs. The sands and gravels were slightly silty to silty, fine to coarse grained with occasional cobbles and boulders, very low to non-plastic, medium dense to dense, slightly moist to dry and brown to gray in color. A sample of the sands and gravels classified as an SM soil in accordance with the Unified Soil Classification System (USCS).

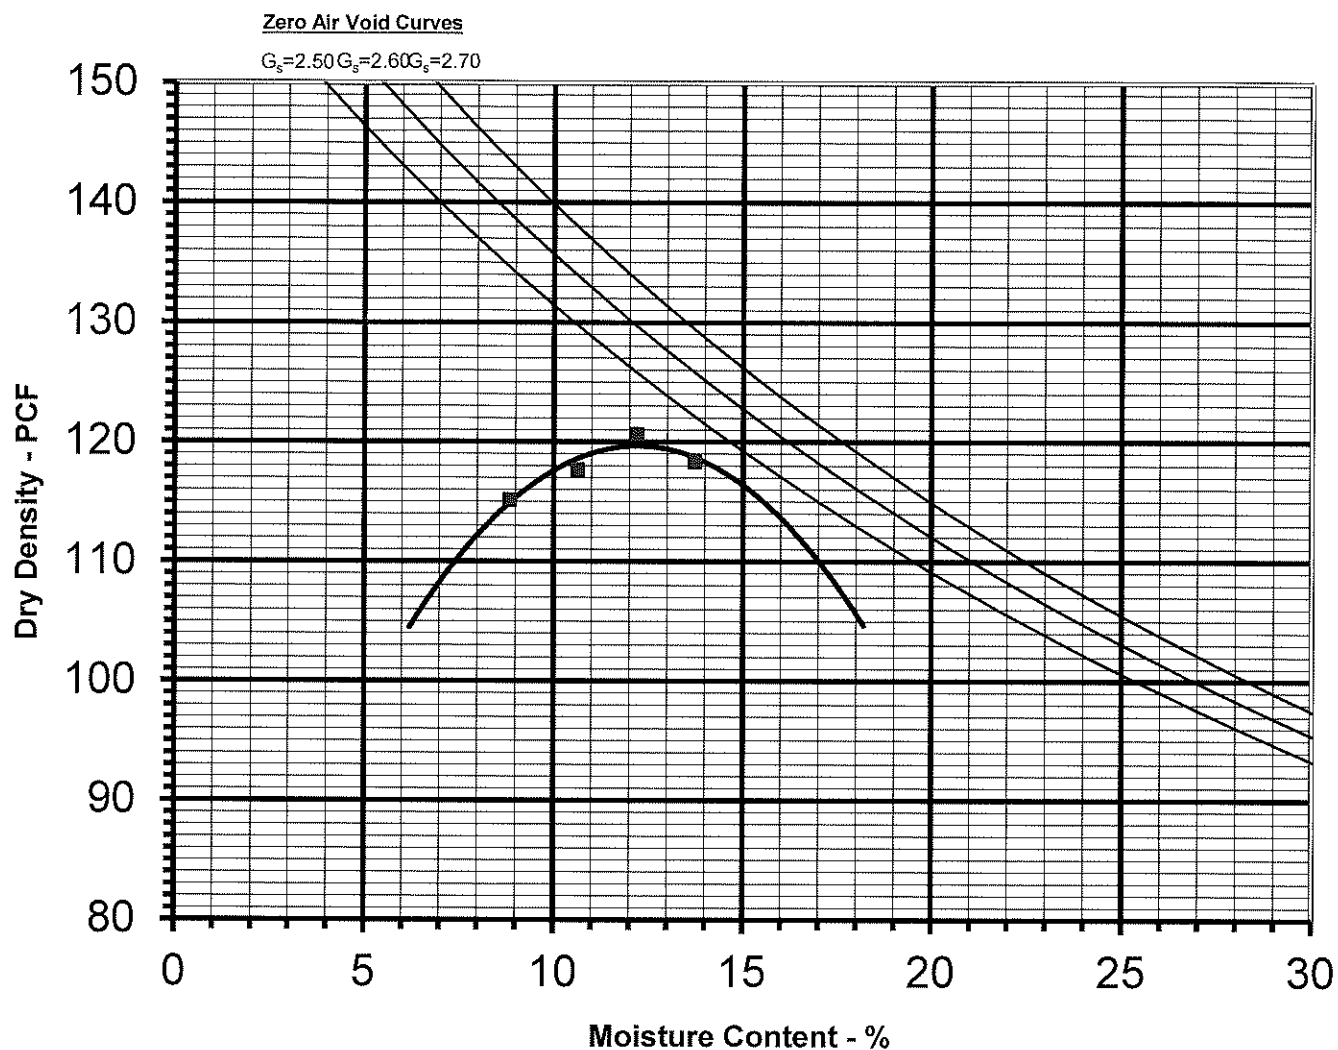
**PROCTOR TEST
RESULTS**

Job Name: Greenhorn Ranch/ Wildblue - New Boulevard Road	
Sample Location: Test Pit 4 @ 5-8'	
Soil Description: Decomposed Granite - Silty Gravelly Sand	
Maximum Dry Density: 119.7 pcf	Opt. Moisture Content: 12.2 %
Liquid Limit: 27 %	Plasticity Index: 2
Gravel: 14 %	Sand: 73 % Silt & Clay (-200): 13 %

Decomposed granite was encountered beneath the sands and gravels in Test Pits 2 and 5 and beneath the topsoil and organic materials in Test Pits 3, 4 and 6. The decomposed granite extended to the maximum depths excavated in Test Pits 2, 4, 5 and 6, and to a depth of 3 feet bgs in Test Pit 3. The decomposed granite was slightly silty to silty, fine to coarse grained with occasional cobble-sized granite fragments, very low to non-plastic, dense to very dense, moist and brown to dark gray in color. Samples of the decomposed granite classified as SM soils in accordance with the USCS. A standard Proctor test was conducted in accordance with ASTM D698 on a large disturbed sample of the decomposed granite to determine the remolded maximum density and optimum moisture content of these materials. The standard Proctor test results are shown in Figure #5.
