Preliminary Subsoil Investigation and Geologic Hazard Evaluation  
Proposed Overlook Park Subdivision/Victory Highway  
A Parcel of Land Located in Section 1, Township 6 North, Range 85 West  
Steamboat Springs, Colorado

Job Number: 08-7985

August 29, 2008

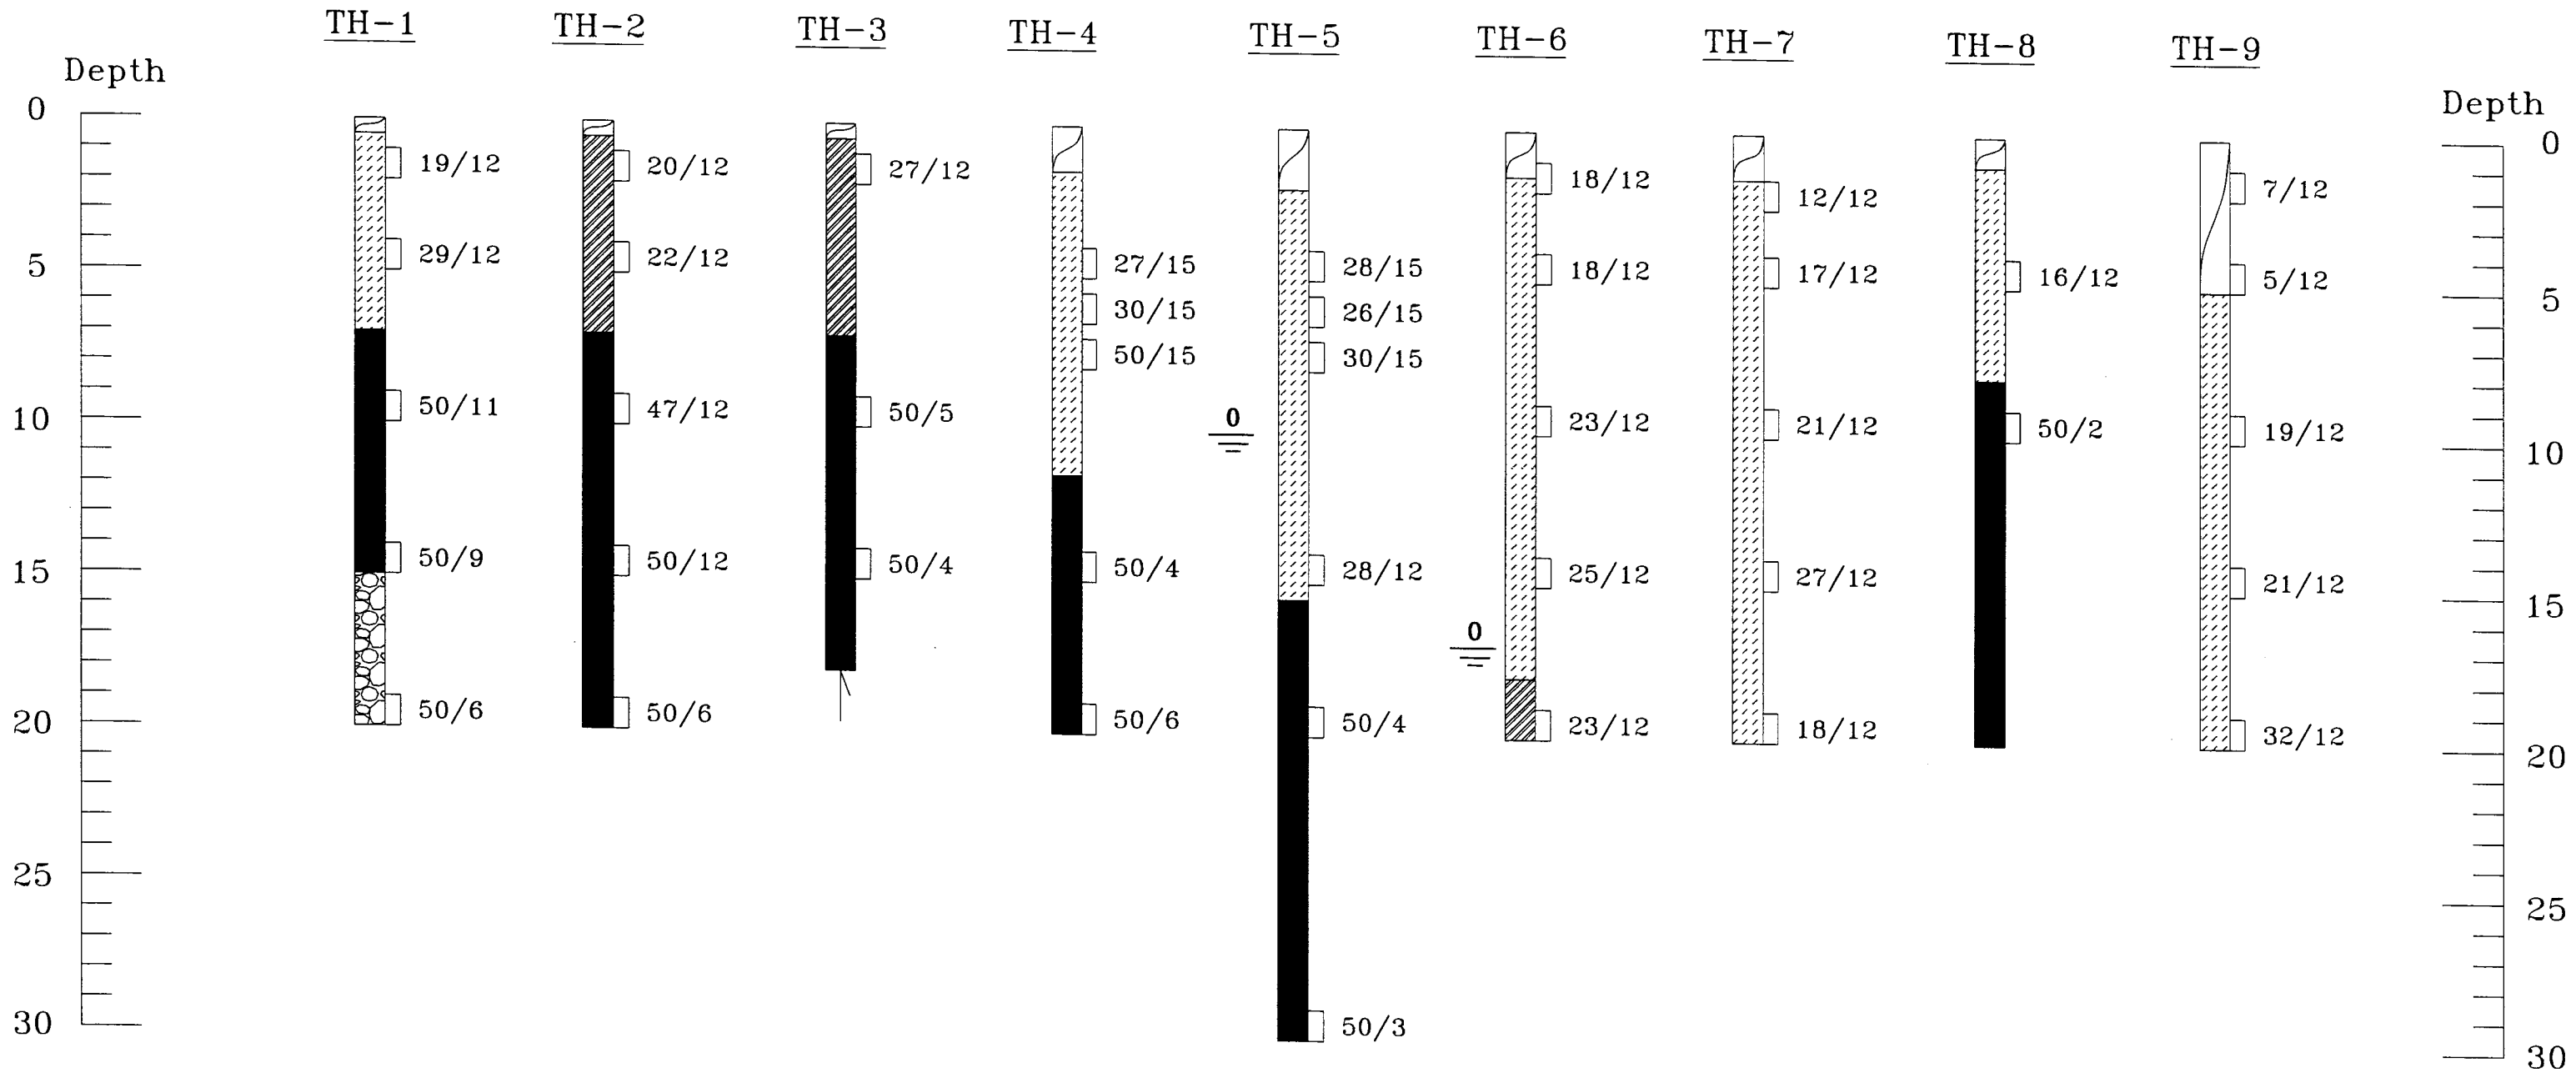
<p><b>NWCC</b> North West Colorado Consultants, Inc. Geotechnical / Environmental Engineering - Materials Testing (970)879-7888 Fax (970)879-7891 2580 Copper Ridge Drive Steamboat Springs, Colorado 80487</p>	Title: Logs of Exploratory Test Holes		
	Job Name: Overlook Park/ Victory Highway		
	Location: Steamboat Springs, Colorado		
	Job No.: 08-7985	Date: 6/27/08	FIGURE: #3

The subsurface conditions encountered in the test holes and test pits were highly variable and generally consisted of a layer of topsoil and organic materials overlying natural clays, sands and gravels, and claystone-shale bedrock materials that extended to the maximum depth investigated, 30 feet. Graphic logs of the exploratory test holes/pits are shown in Figures #3 and #4, and the associated Legend and Notes are presented in Figure #5.

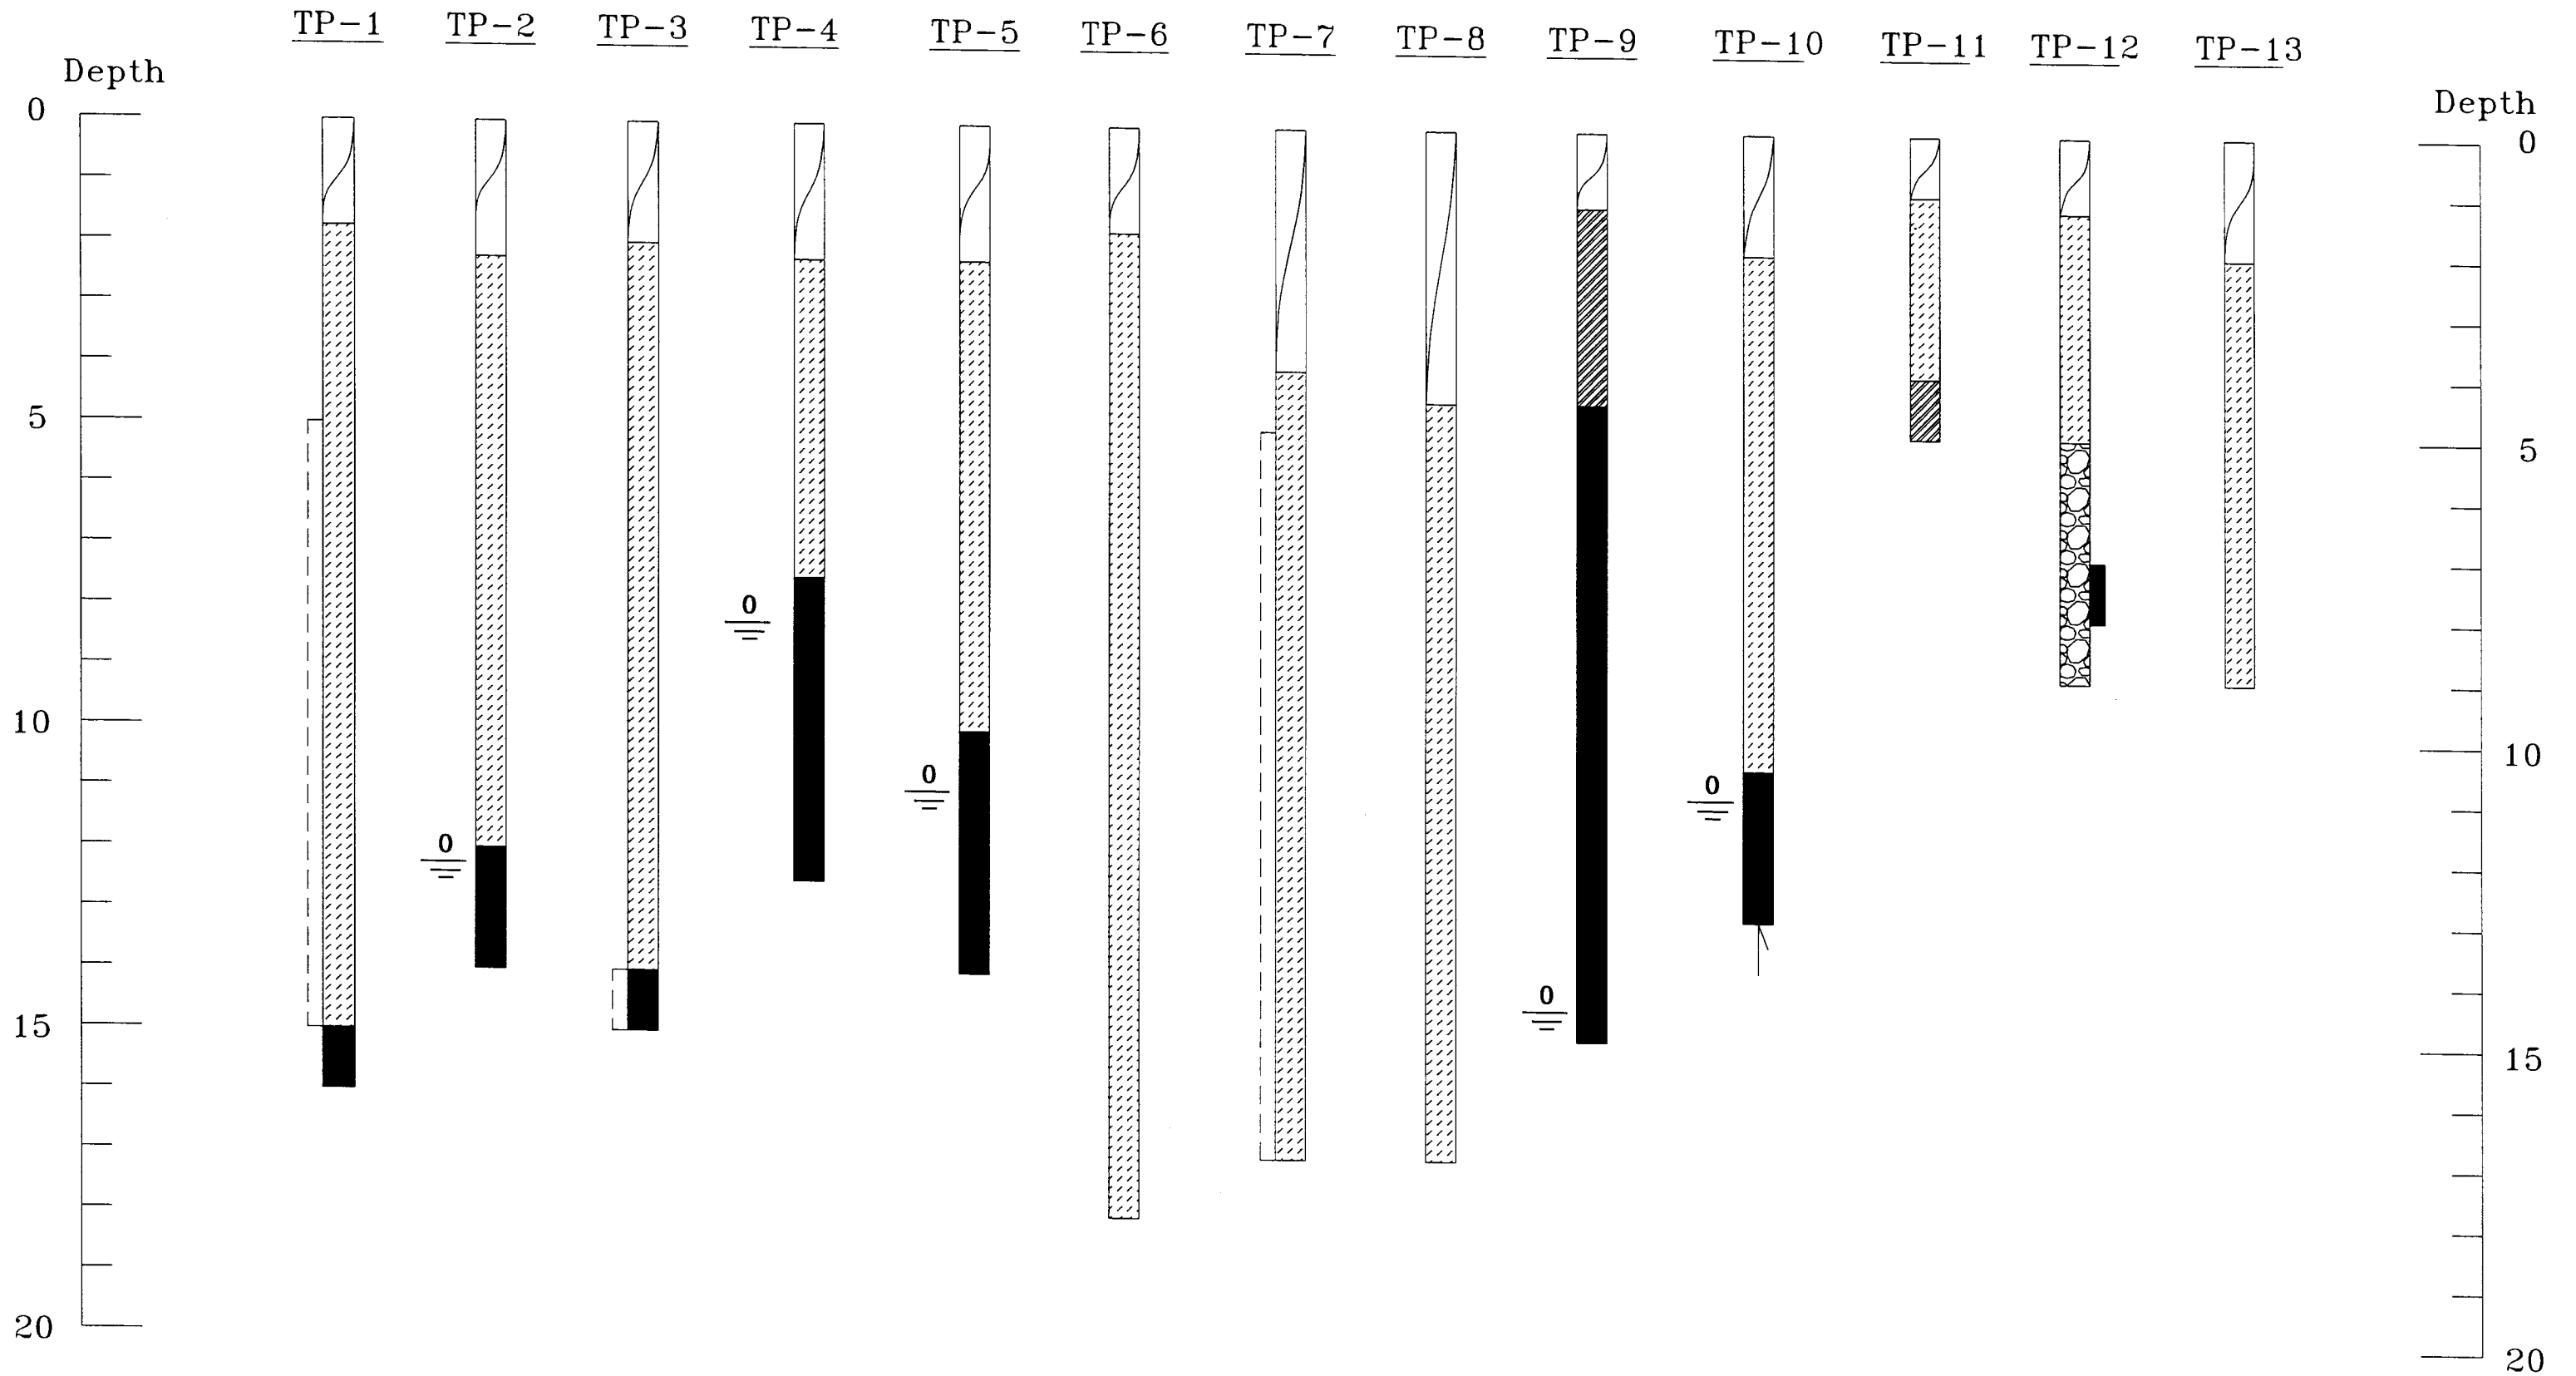
<p><b>NWCC</b> North West Colorado Consultants, Inc. Geotechnical / Environmental Engineering - Materials Testing (970)879-7888 Fax (970)879-7891 2580 Copper Ridge Drive Steamboat Springs, Colorado 80487</p>	Title: Logs of Exploratory Test Pits		
	Job Name: Overlook Park/ Victory Highway		
	Location: Steamboat Springs, Colorado		
	Job No.: 08-7985	Date: 6/27/08	FIGURE: #4

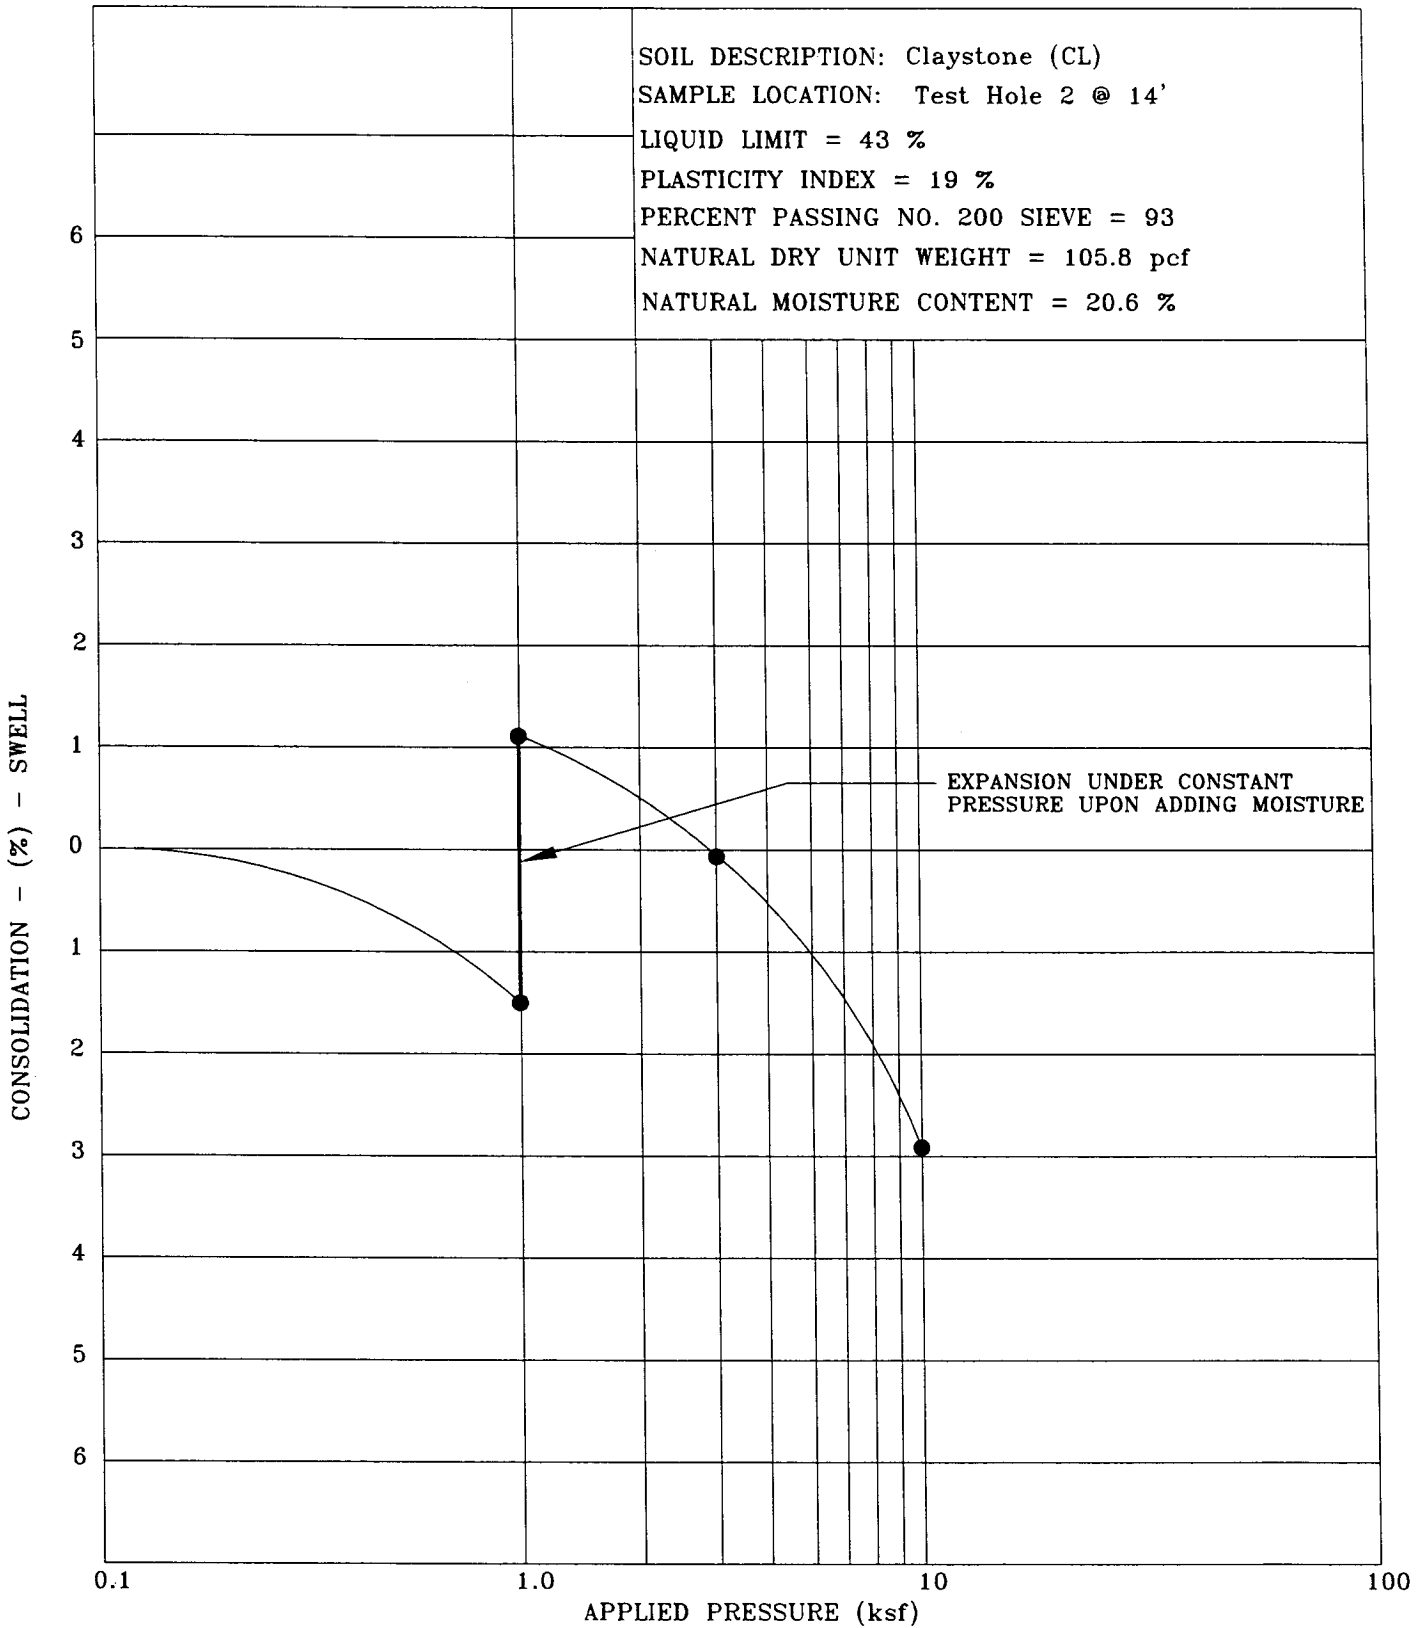
Title: SWELL-CONSOLIDATION TEST RESULTS

SOIL DESCRIPTION: Claystone (CL)  
 SAMPLE LOCATION: Test Hole 2 @ 14'  
 LIQUID LIMIT = 43 %  
 PLASTICITY INDEX = 19 %  
 PERCENT PASSING NO. 200 SIEVE = 93  
 NATURAL DRY UNIT WEIGHT = 105.8 pcf  
 NATURAL MOISTURE CONTENT = 20.6 %

Swell-consolidation testing conducted on relatively undisturbed samples of the natural clays and claystone-shale bedrock materials indicate that the materials tested will exhibit a moderate to high swell potential when wetted under a constant load. As noted previously, the swell-consolidation test results are shown in Figures #6 through #9, and all of the other test results are summarized in the attached Table 1.

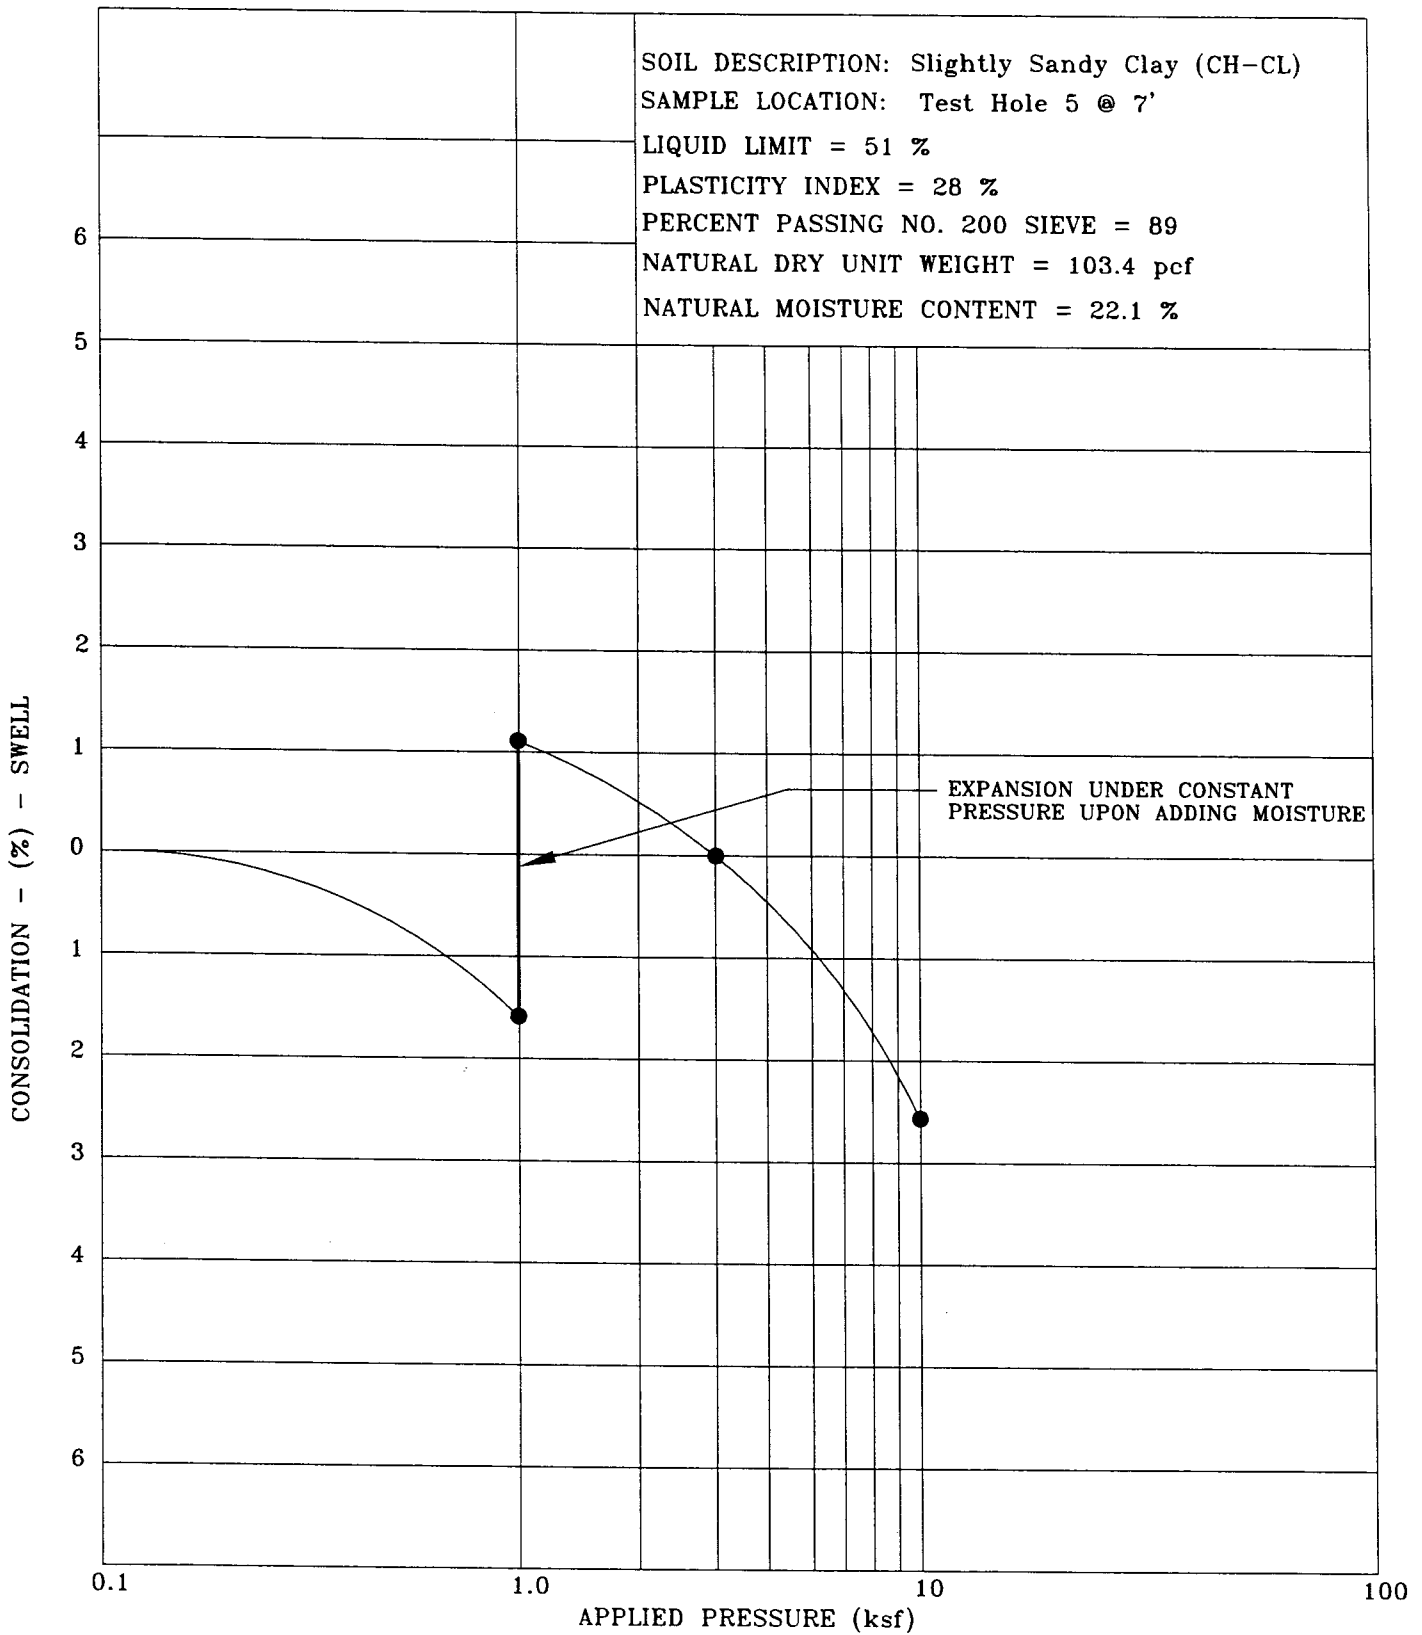
Title: SWELL-CONSOLIDATION TEST RESULTS

SOIL DESCRIPTION: Slightly Sandy Clay (CH-CL)  
 SAMPLE LOCATION: Test Hole 5 @ 7'  
 LIQUID LIMIT = 51 %  
 PLASTICITY INDEX = 28 %  
 PERCENT PASSING NO. 200 SIEVE = 89  
 NATURAL DRY UNIT WEIGHT = 103.4 pcf  
 NATURAL MOISTURE CONTENT = 22.1 %

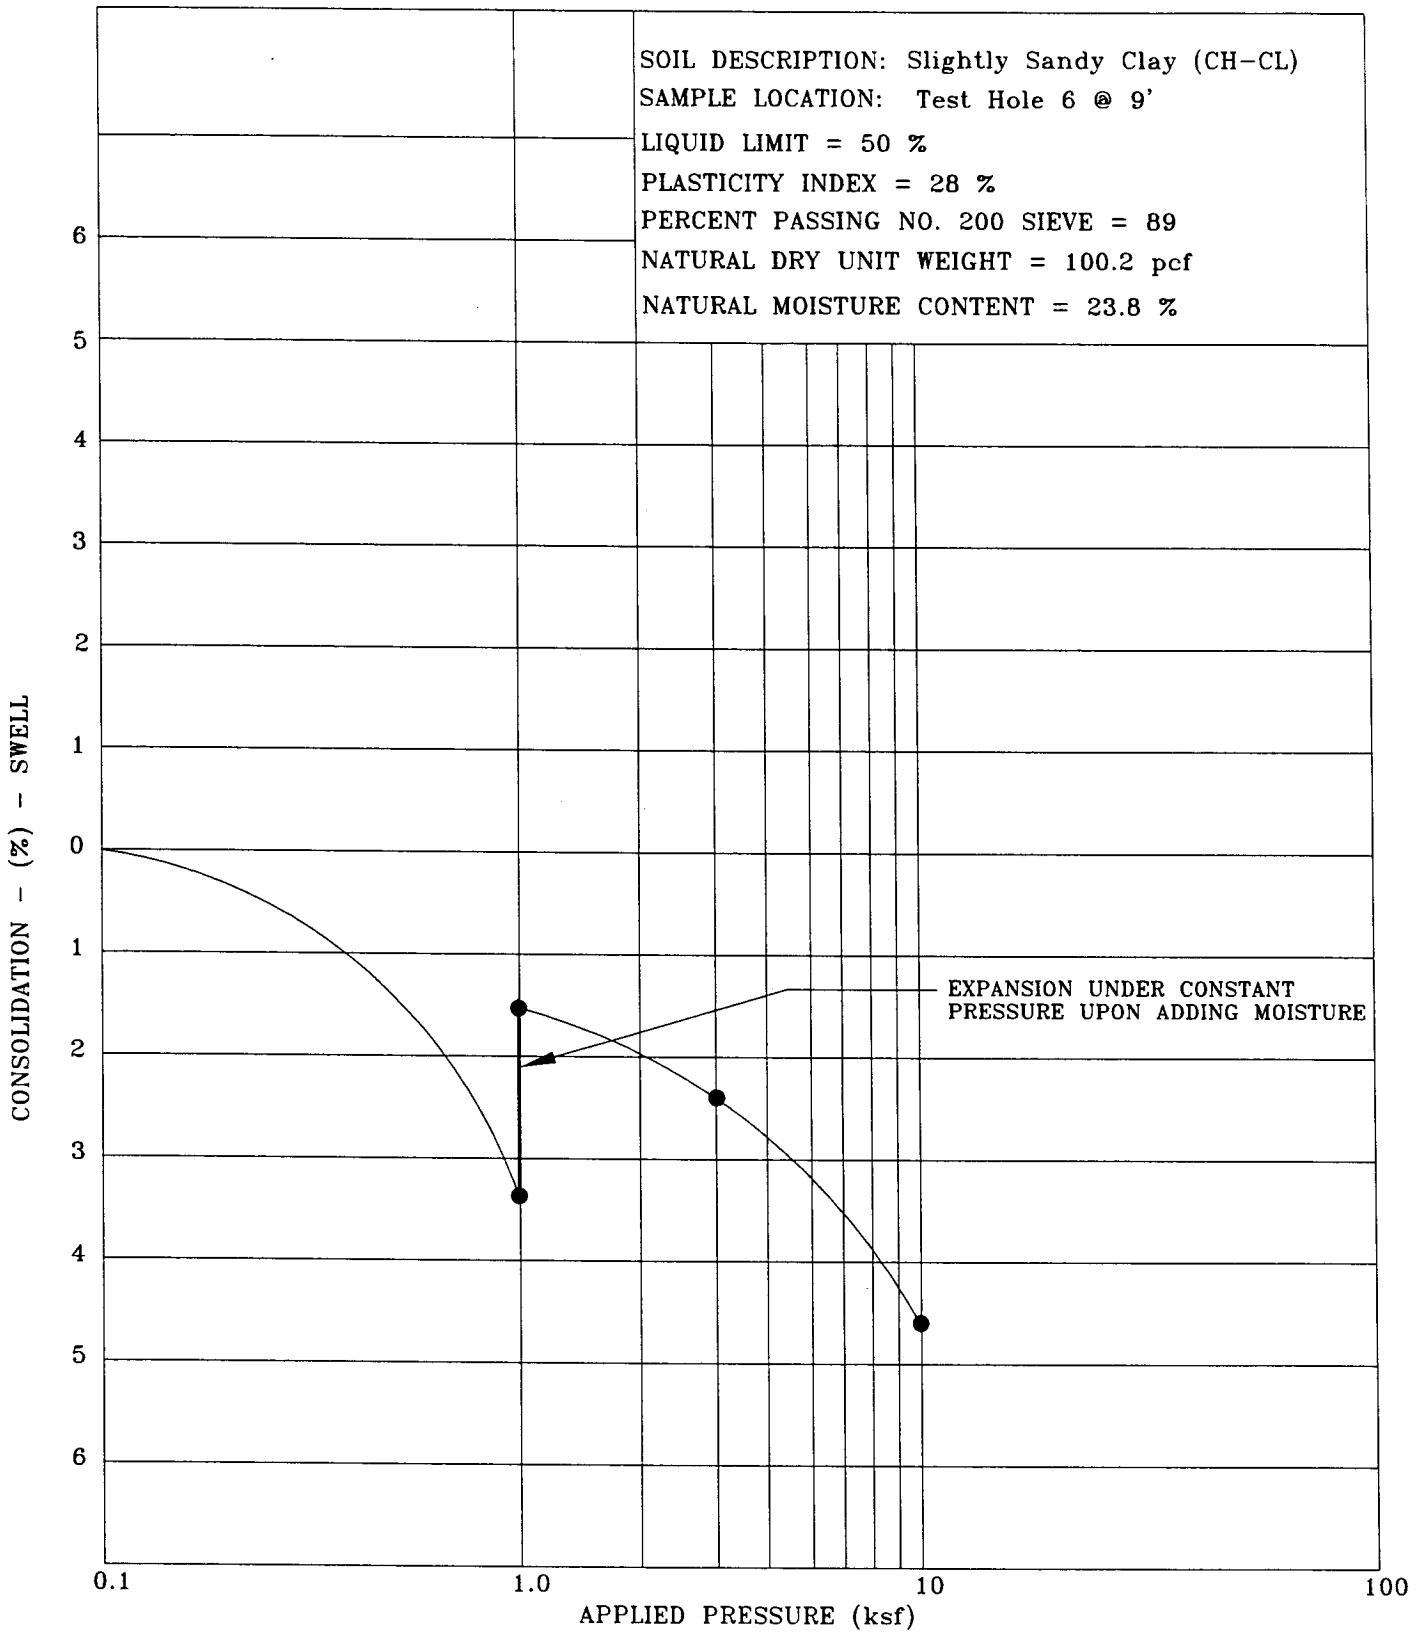
Title: SWELL-CONSOLIDATION TEST RESULTS

SOIL DESCRIPTION: Slightly Sandy Clay (CH-CL)  
 SAMPLE LOCATION: Test Hole 6 @ 9'  
 LIQUID LIMIT = 50 %  
 PLASTICITY INDEX = 28 %  
 PERCENT PASSING NO. 200 SIEVE = 89  
 NATURAL DRY UNIT WEIGHT = 100.2 pcf  
 NATURAL MOISTURE CONTENT = 23.8 %

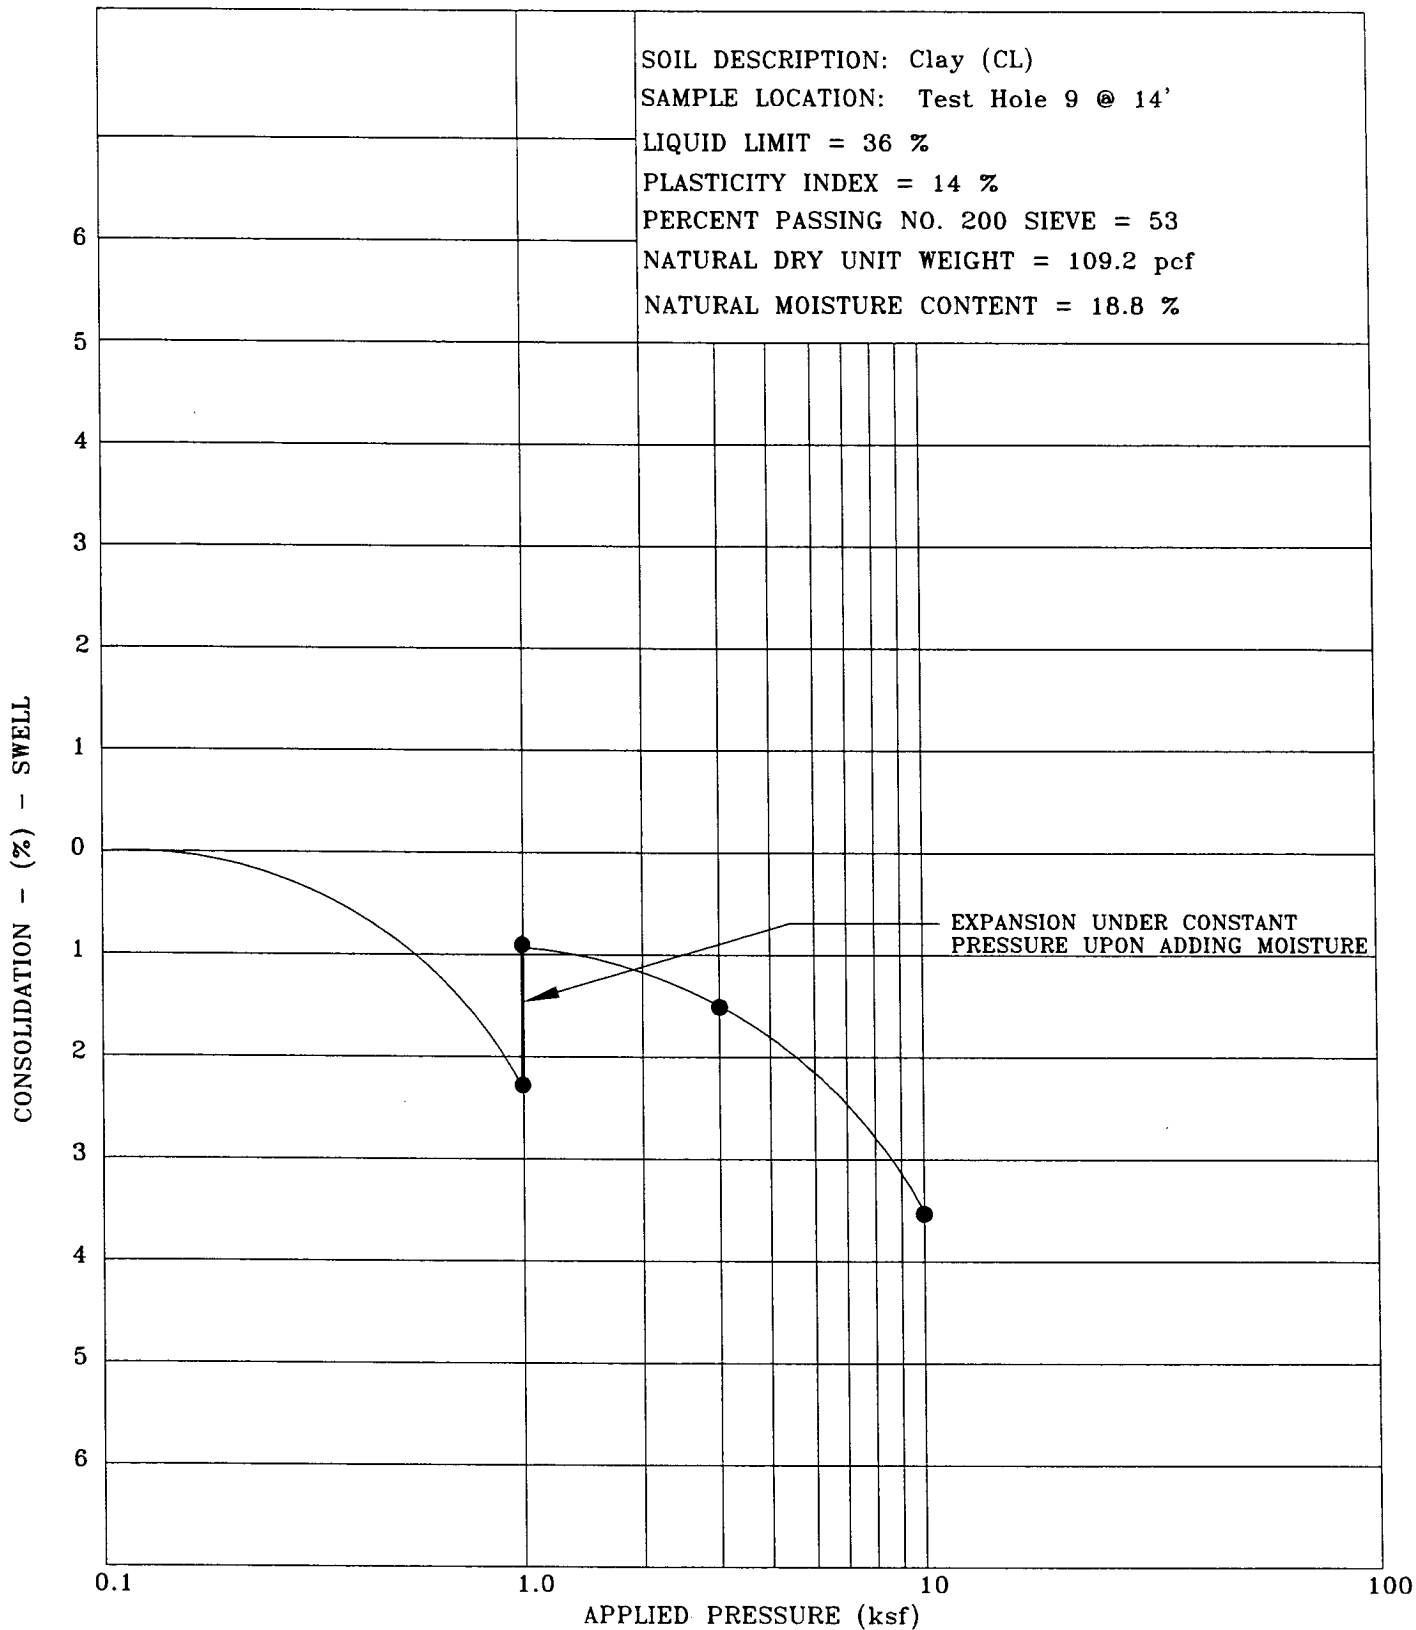
Title: SWELL-CONSOLIDATION TEST RESULTS

SOIL DESCRIPTION: Clay (CL)  
 SAMPLE LOCATION: Test Hole 9 @ 14'  
 LIQUID LIMIT = 36 %  
 PLASTICITY INDEX = 14 %  
 PERCENT PASSING NO. 200 SIEVE = 53  
 NATURAL DRY UNIT WEIGHT = 109.2 pcf  
 NATURAL MOISTURE CONTENT = 18.8 %

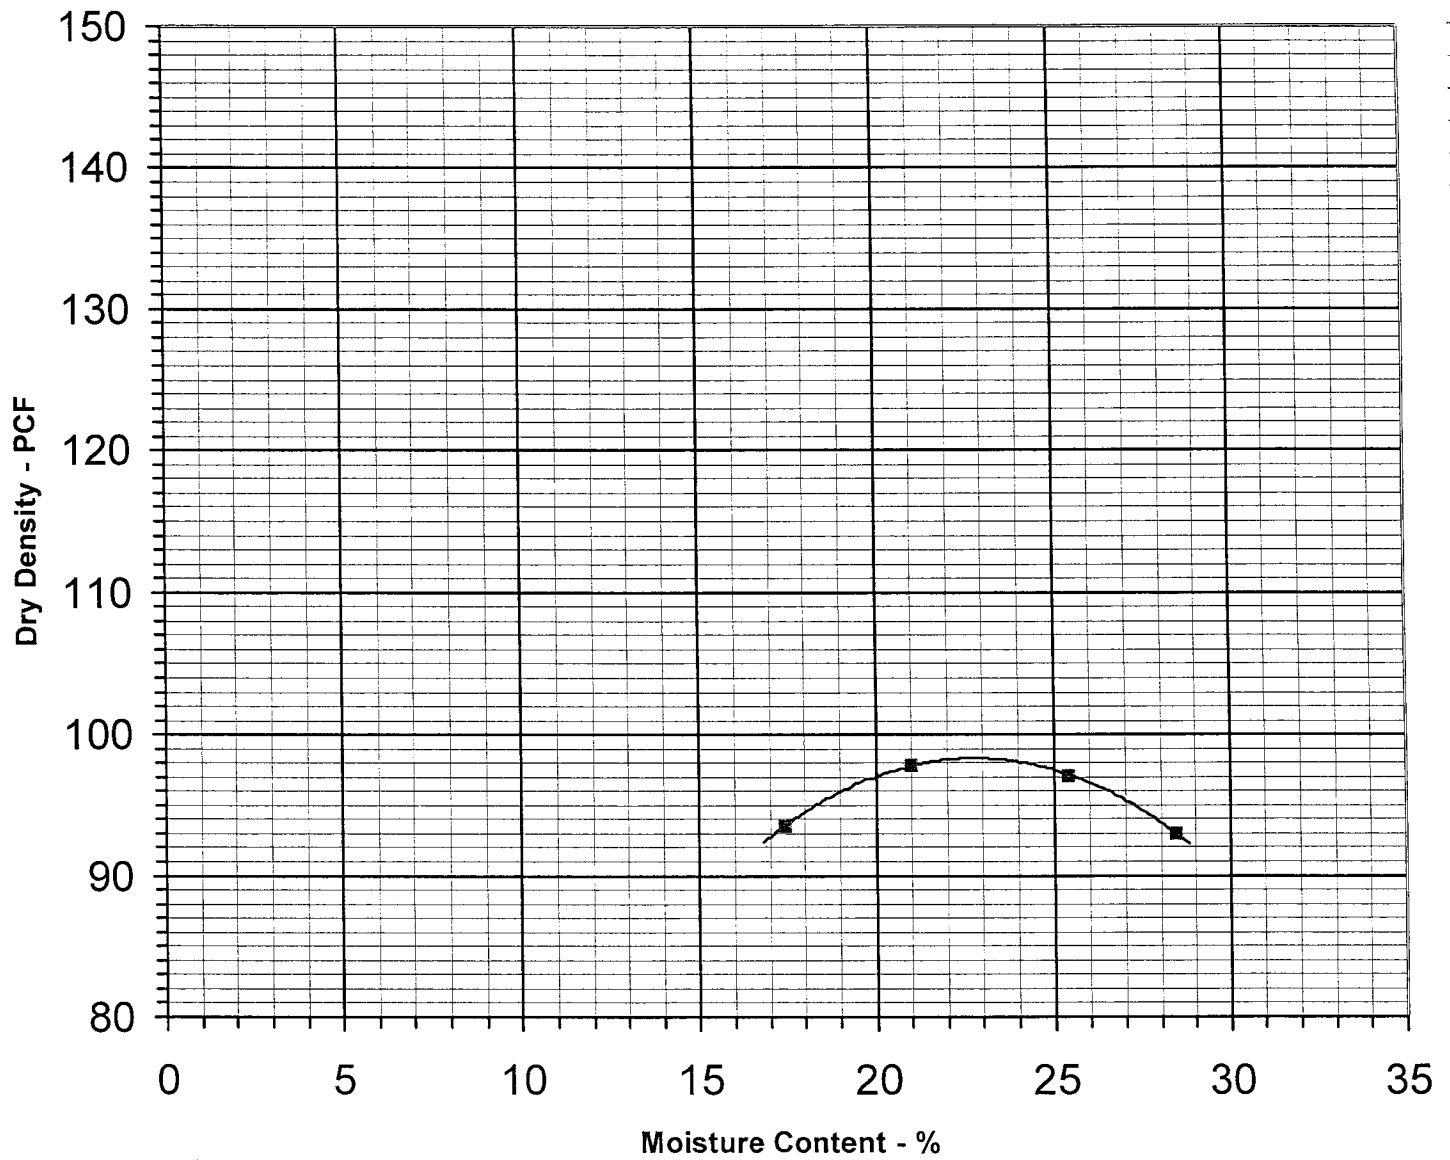
Job Name: Overlook Park/Victory Highway		<b>PROCTOR TEST RESULTS</b>	
Sample Location: Test Pit 1 @ 5-15'			
Soil Description: Slightly Sandy Clay		Sample No. 1P	
Maximum Dry Density: 98.3 pcf	Opt. Moisture Content: 22.9 %	Procedure: ASTM D698	
Liquid Limit: 50	Plasticity Index: 26	Date: 5/22/08	
Gravel: 0 %	Sand: 7 %	Silt & Clay (-200): 93 %	Job. No. 08-7985 Figure: #10

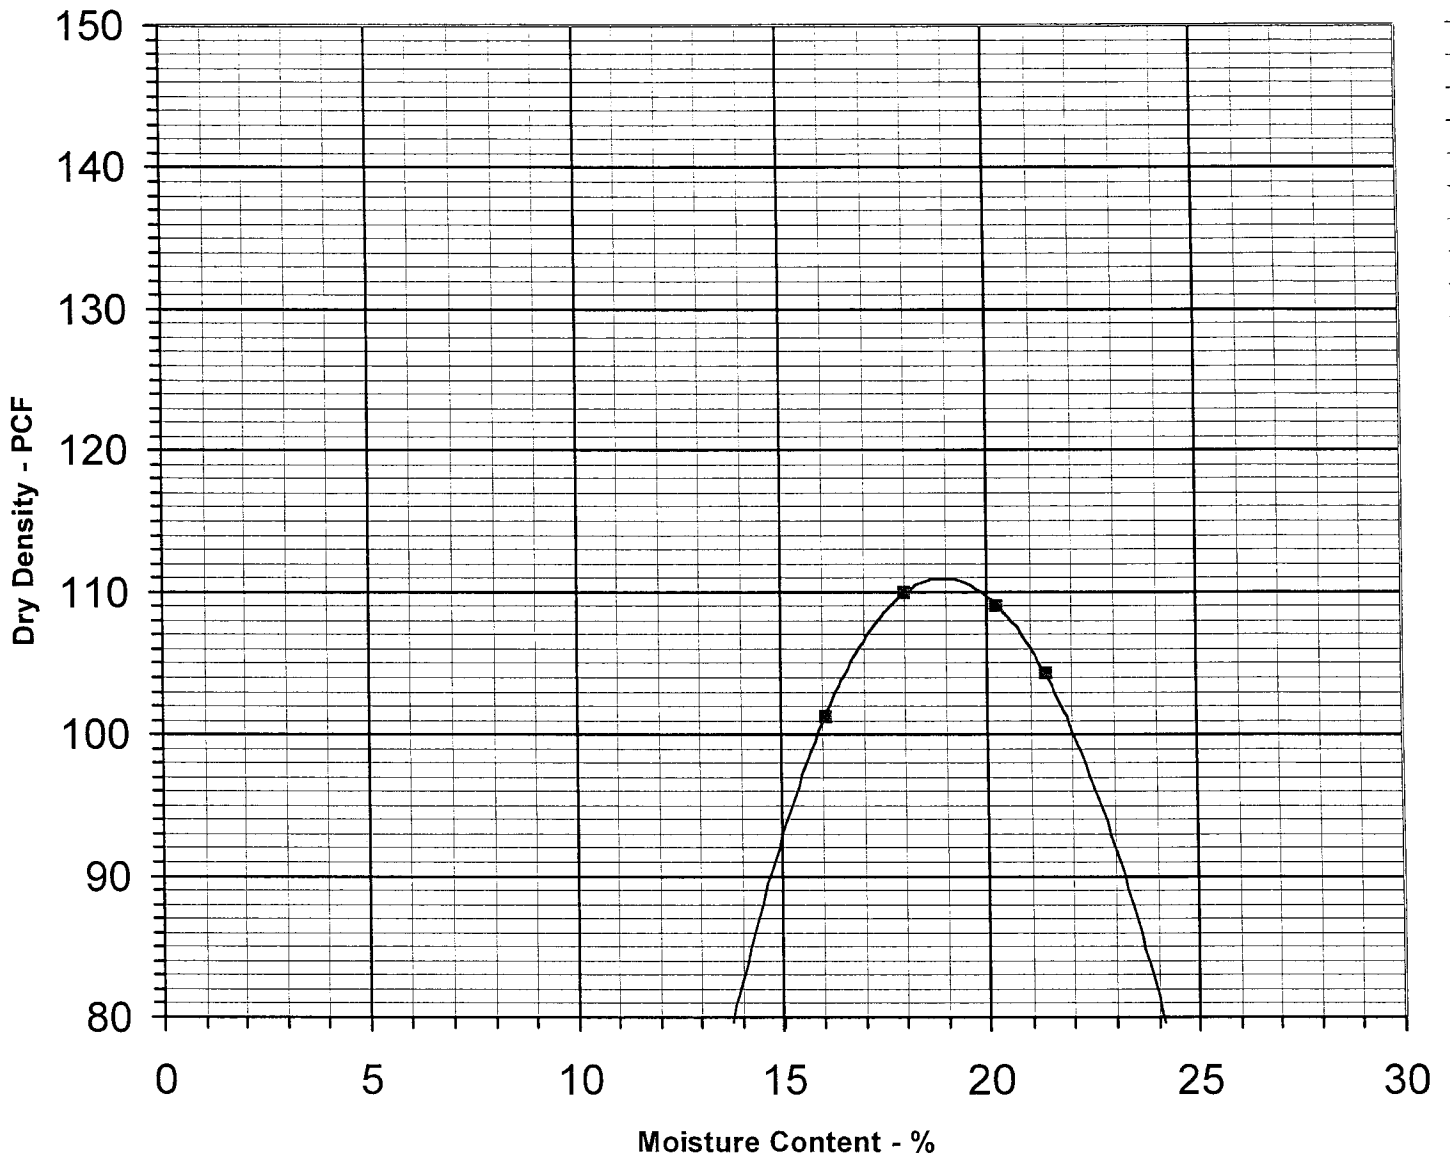
Job Name: Overlook Park/Victory Highway		<b>PROCTOR TEST RESULTS</b>
Sample Location: TP 3 @ 14-15'		
Soil Description: Claystone-Shale		Sample No. 2P
Maximum Dry Density: 110.8 pcf	Opt. Moisture Content: 19.0 %	Procedure: ASTM D698
Liquid Limit: 39	Plasticity Index: 18	Date: 5/22/08
Gravel: 0 %	Sand: 10 %	Silt & Clay (-200): 90 %
		Job. No. 08-7985 Figure: #11
