RIVERFRONT PARK HOA

A DECK REPAIR FOR:  
BUILDING 1 - COLORADO PUBLIC DEFENDER'S OFFICE

DRAWN BY: SJM  
PROJECT # 17075  
SIDEWALL  
FLASHING  
DETAILS

S-2

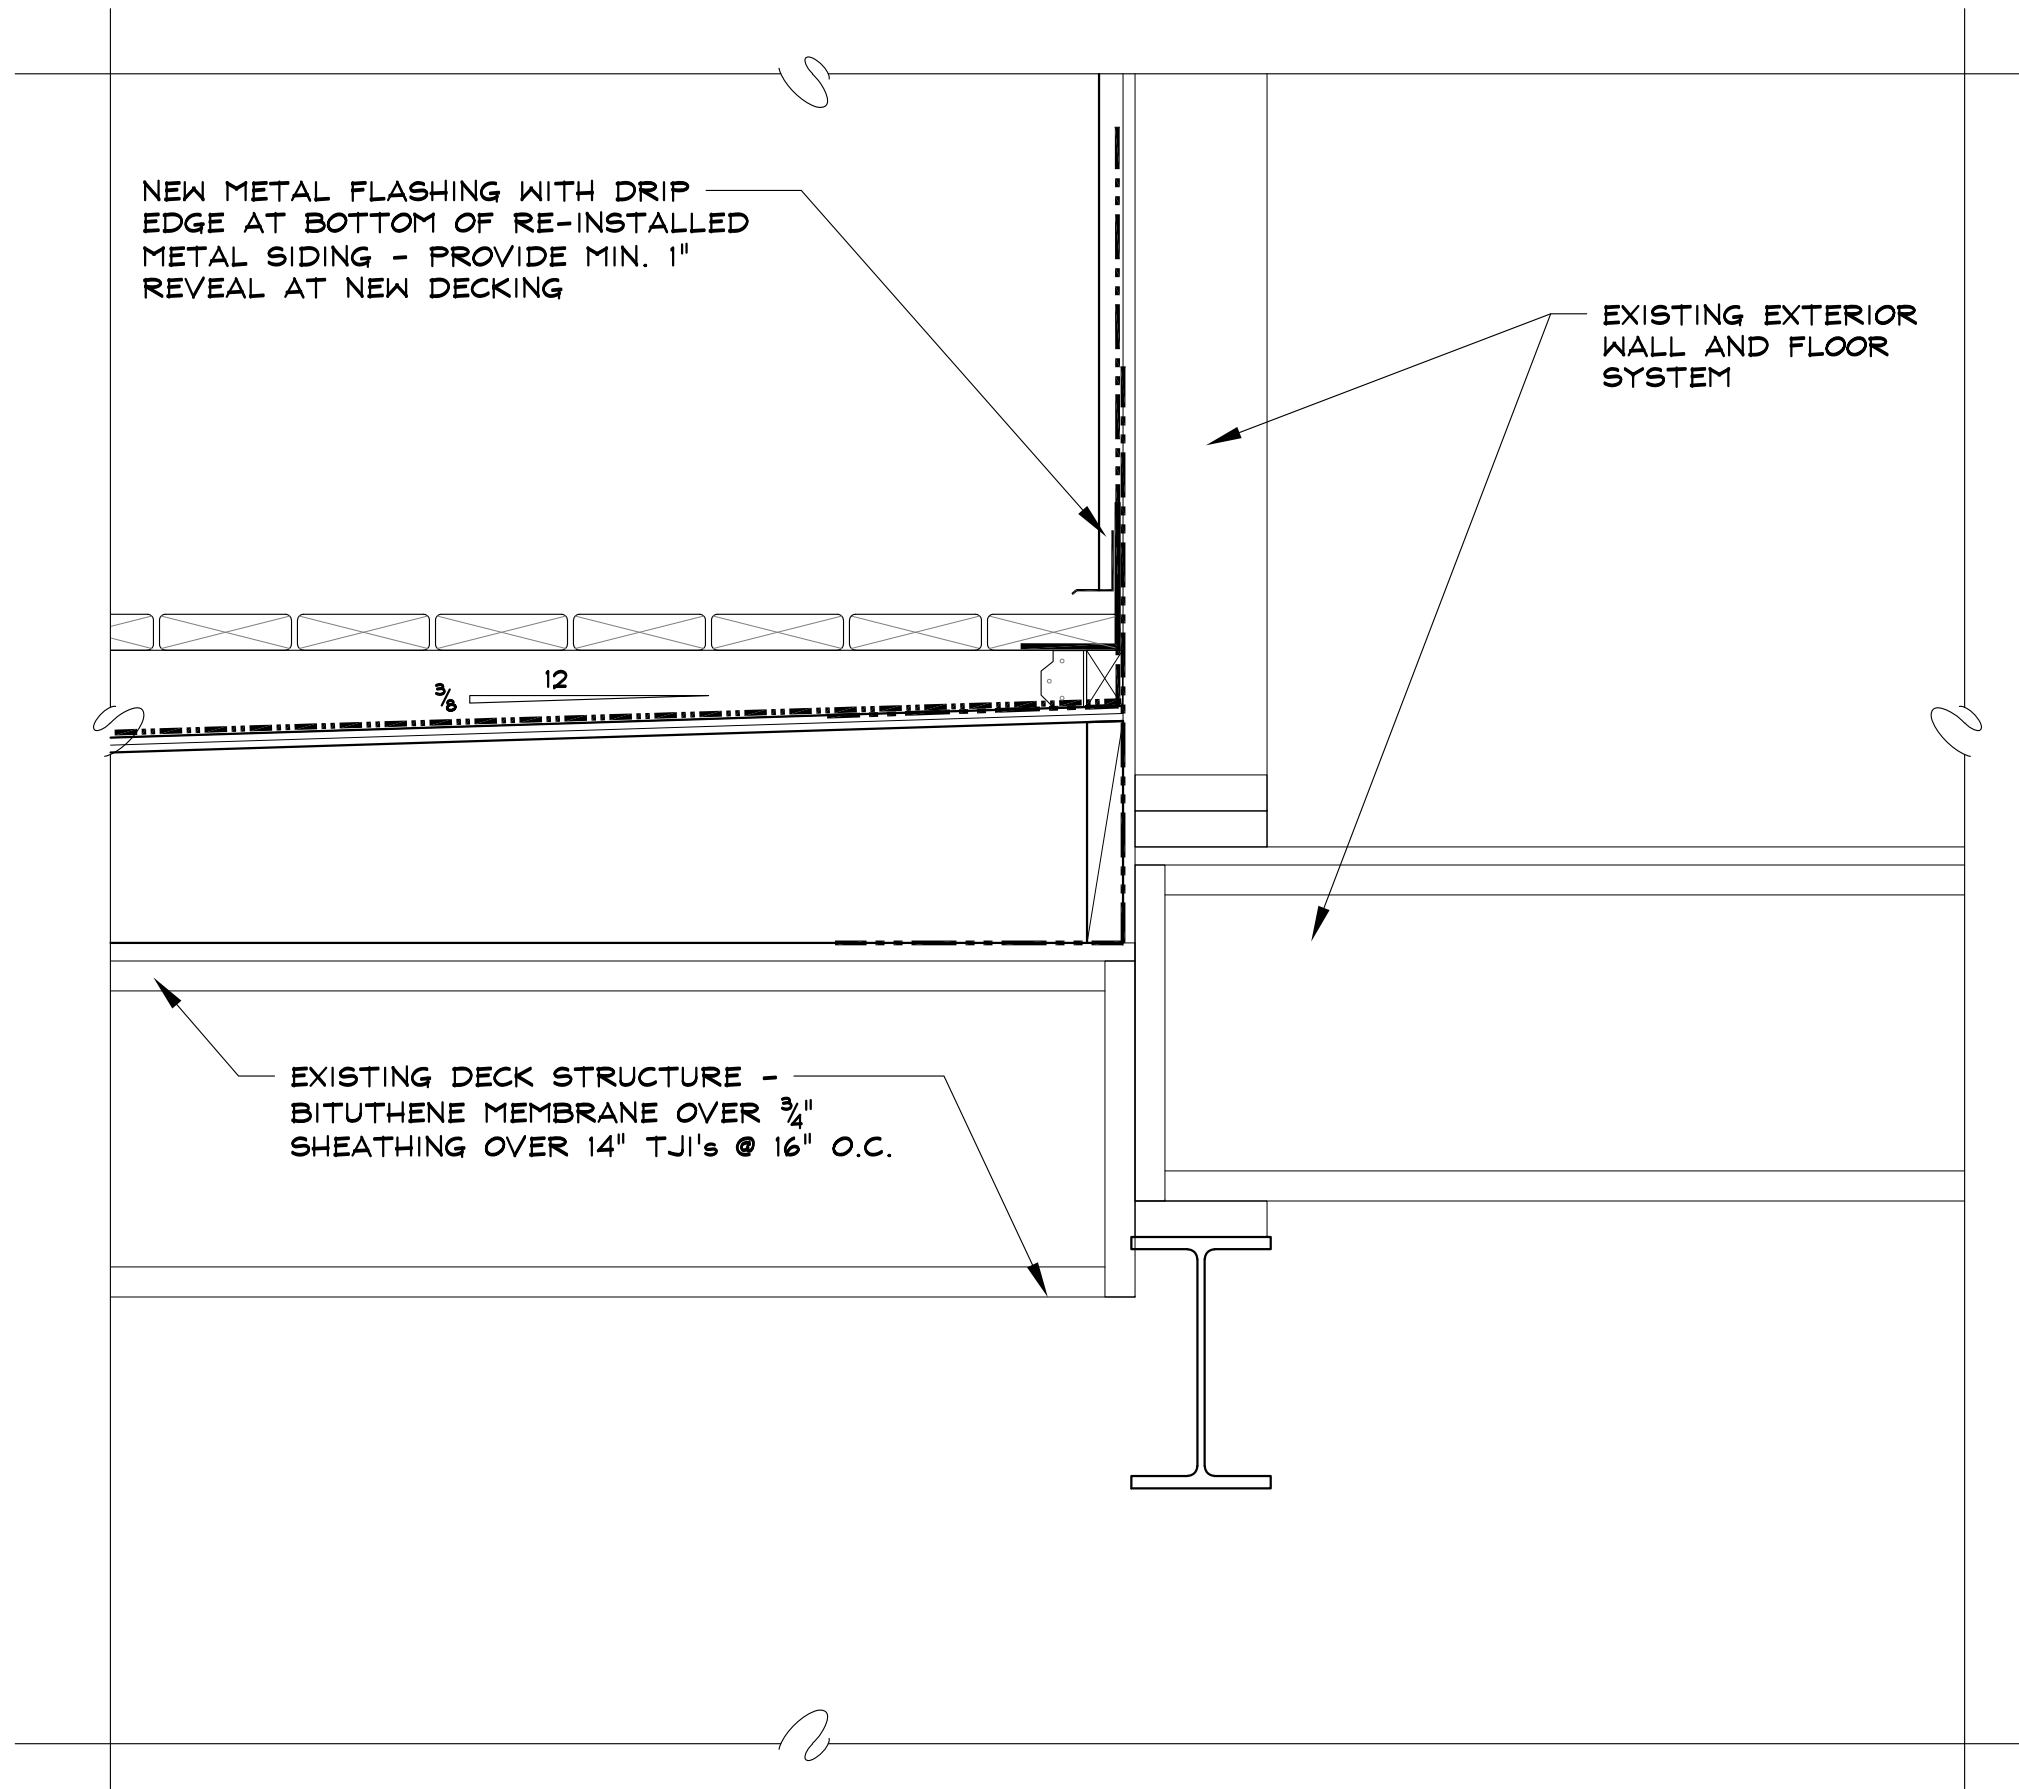
④ TYPICAL SIDEWALL FLASHING - STEP 4  
TYPICAL - TO BE COMPLETED AFTER DEMOLITION - REFER TO SHEETS AD-1 & S-1 DATED 05-23-18

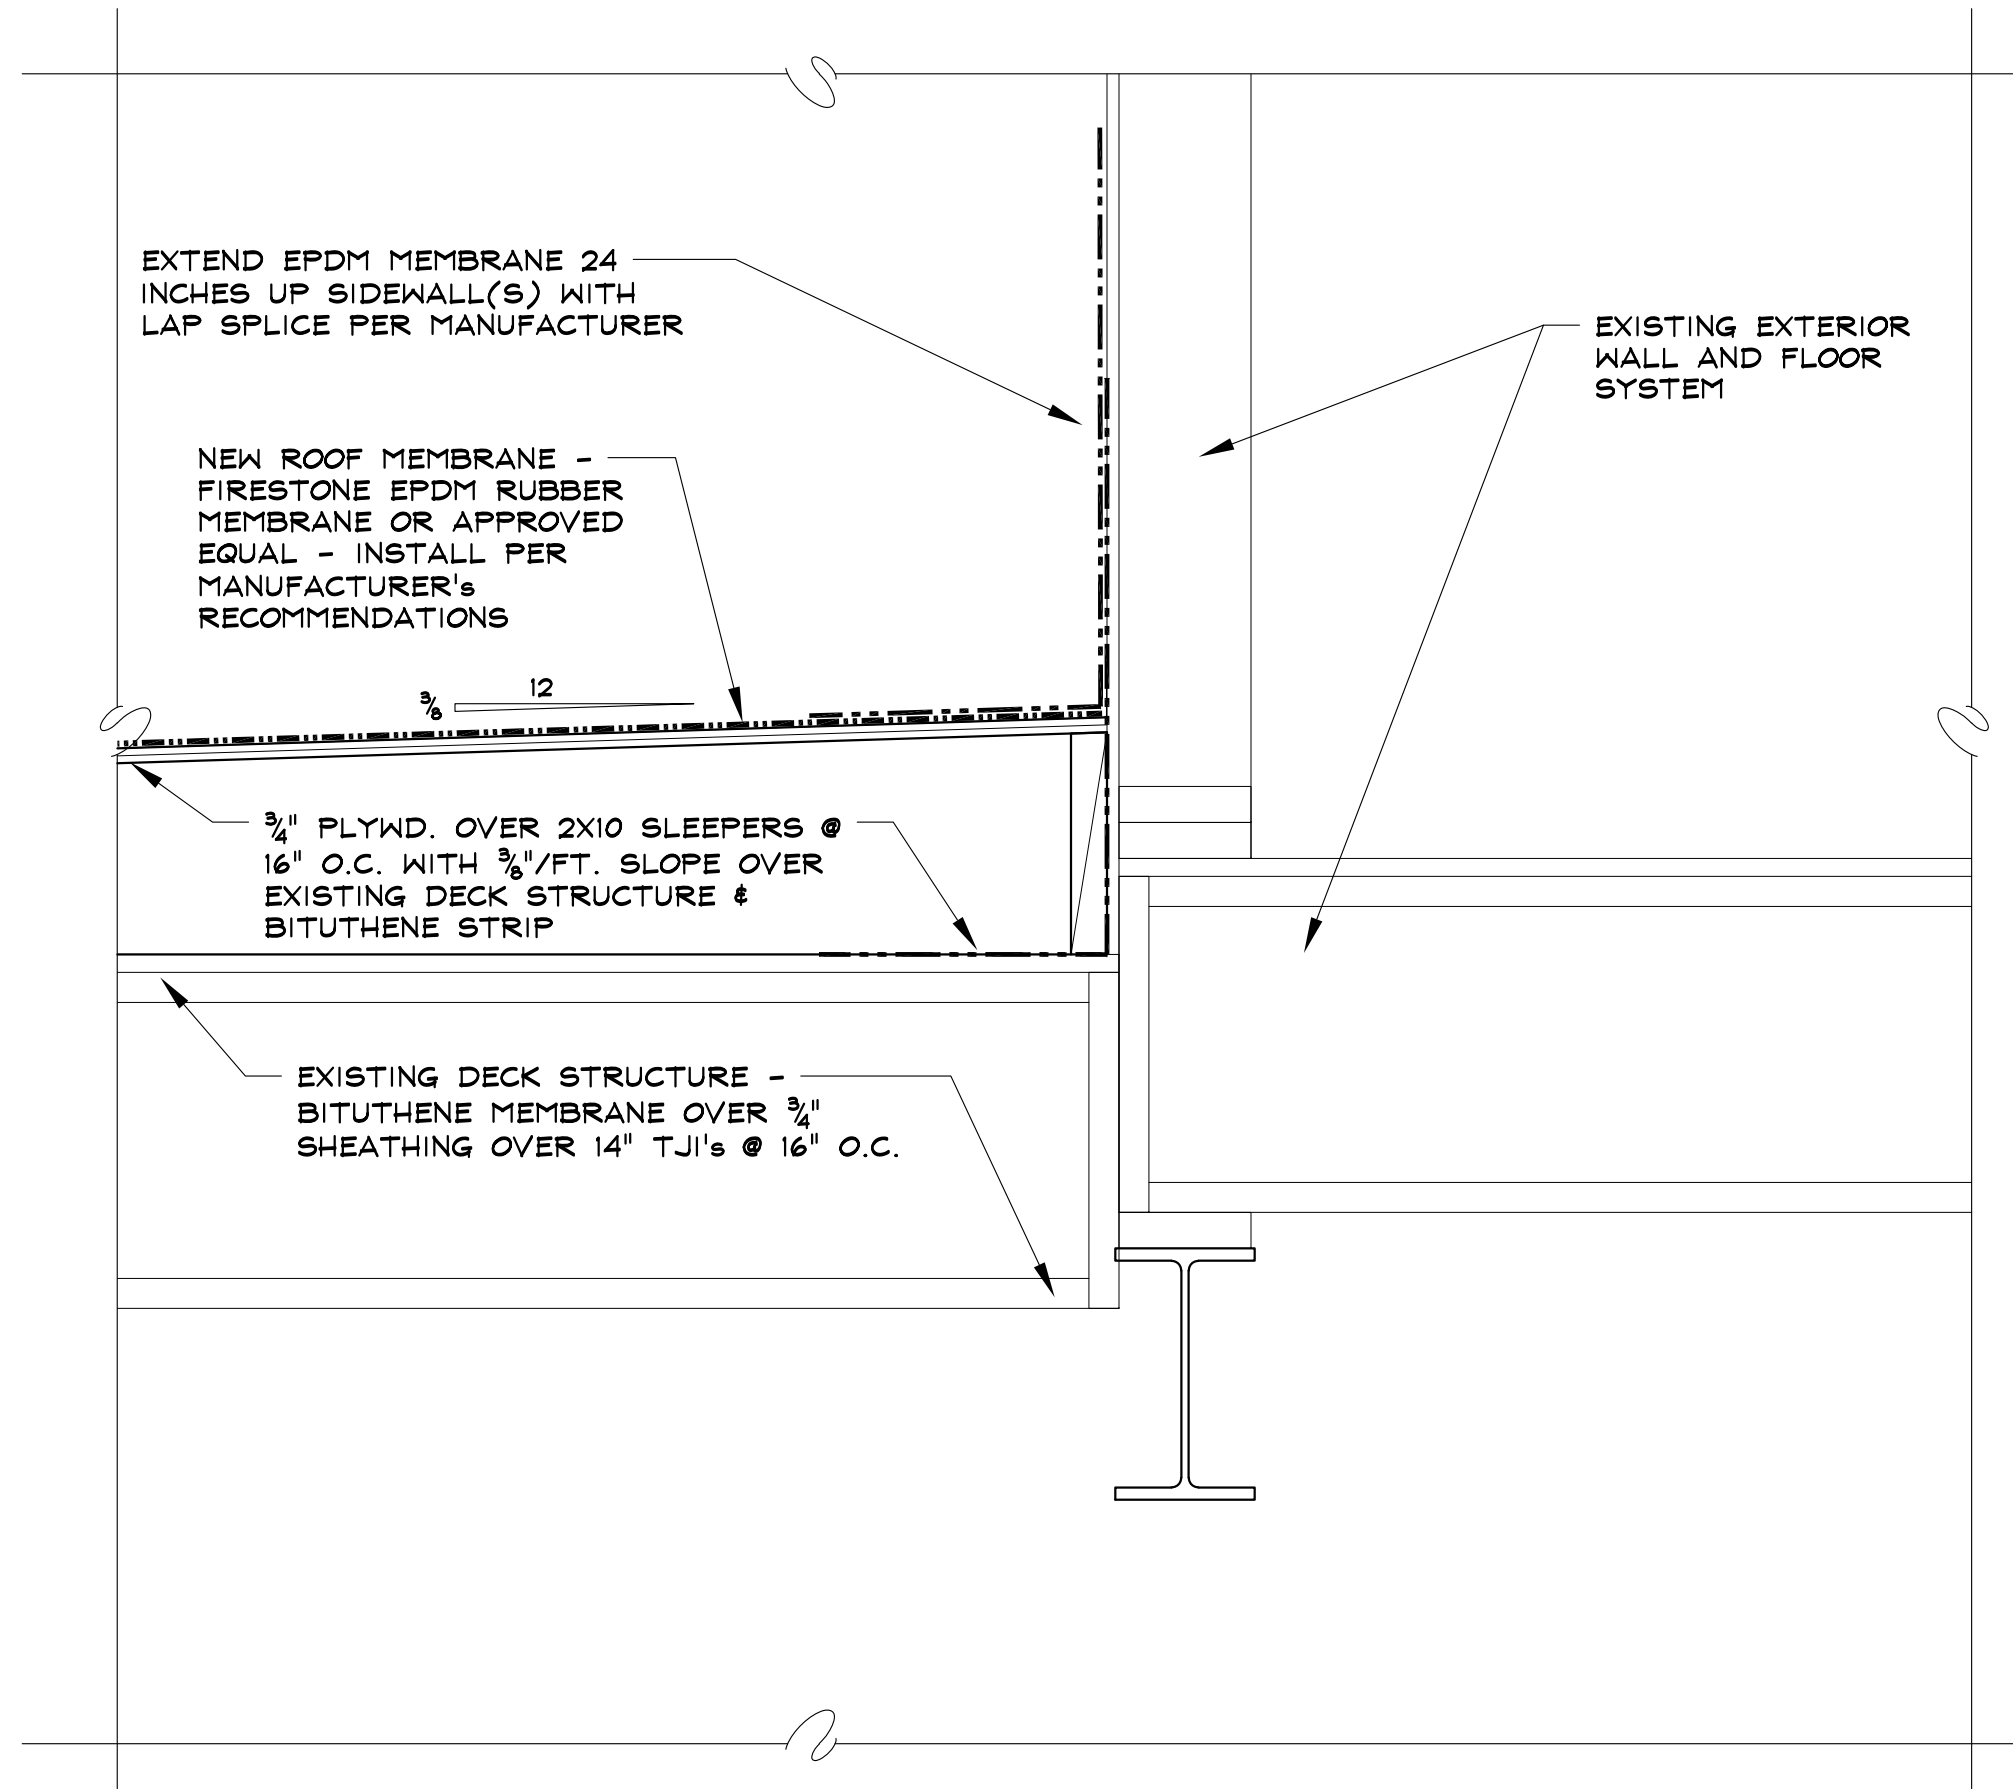
② TYPICAL SIDEWALL FLASHING - STEP 2  
TYPICAL - TO BE COMPLETED AFTER DEMOLITION - REFER TO SHEETS AD-1 & S-1 DATED 05-23-18

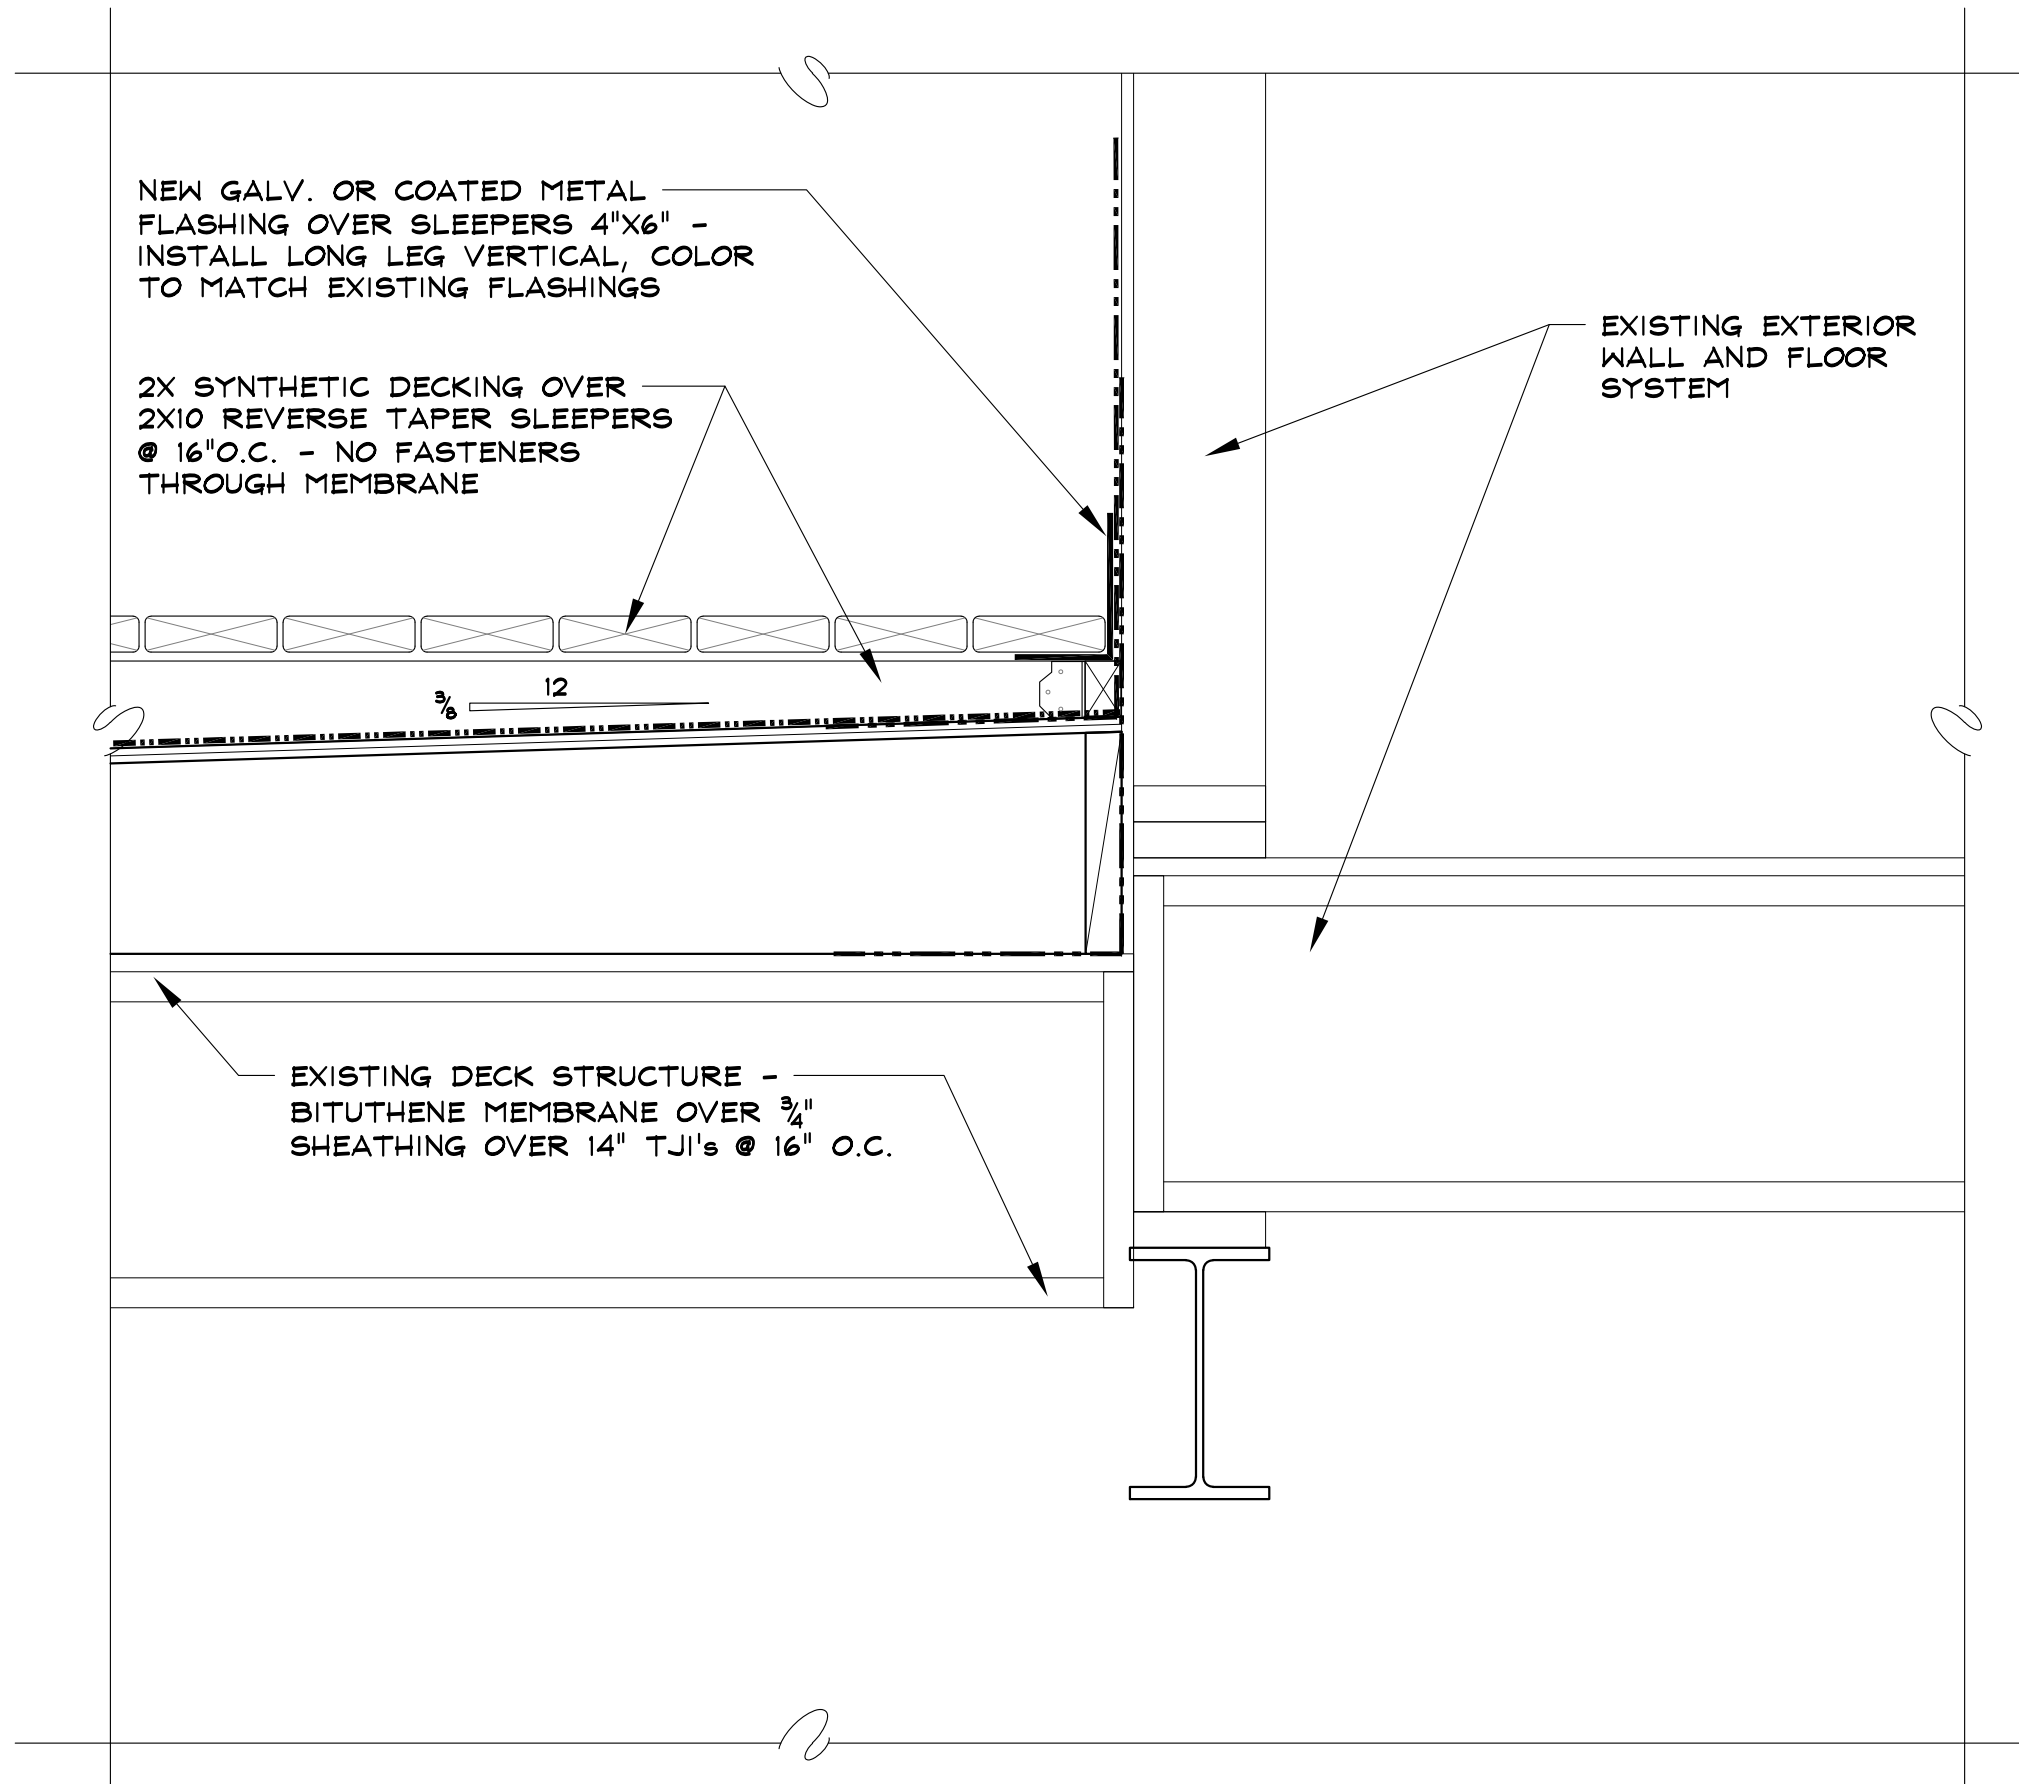
③ TYPICAL SIDEWALL FLASHING - STEP 3  
TYPICAL - TO BE COMPLETED AFTER DEMOLITION - REFER TO SHEETS AD-1 & S-1 DATED 05-23-18

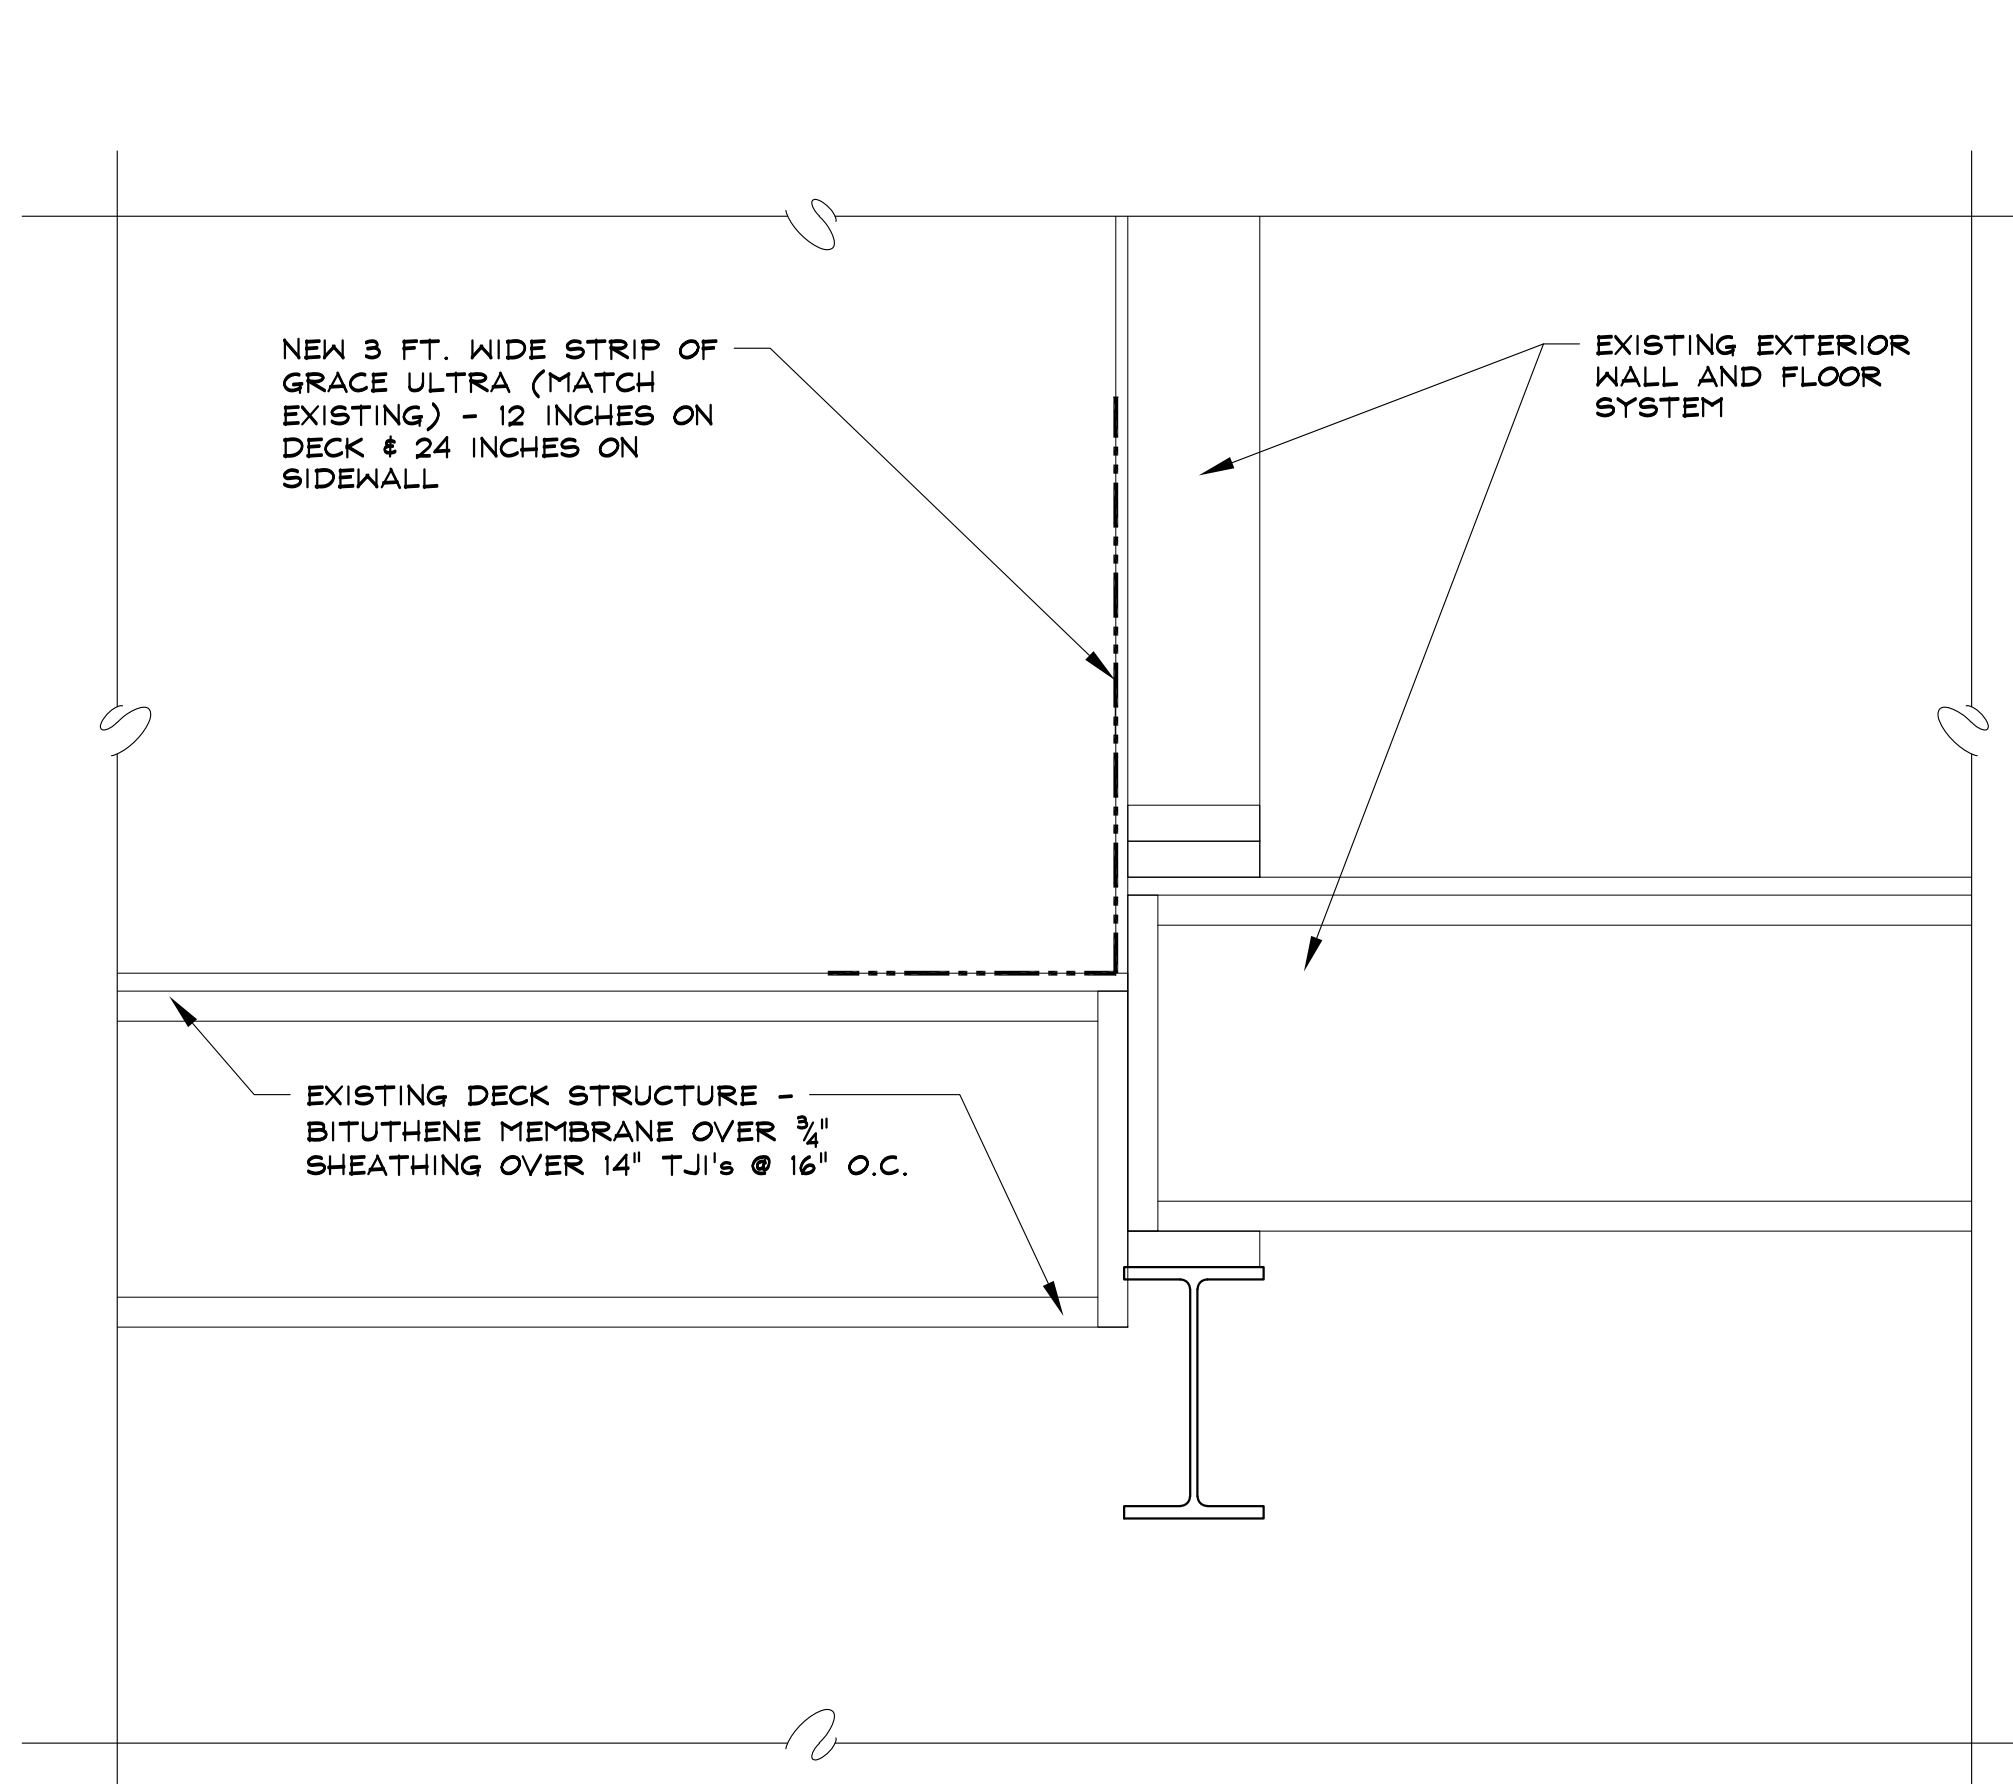
① TYPICAL SIDEWALL FLASHING - STEP 1  
TYPICAL - TO BE COMPLETED AFTER DEMOLITION - REFER TO SHEETS AD-1 & S-1 DATED 05-23-18
