Reference: Bear Claw II Exterior Remodel
RE: Ski Entry Slab Repair
2420 Ski Trail Lane
Steamboat Springs, CO
Anthem Job No. 17-173

As requested, Anthem came to the site on Tuesday, August 6th to observe the cut concrete edge at the Ski Entry on the north side of the building and how the existing condition corresponds to the repair detail Anthem issued on July 12, 2019.

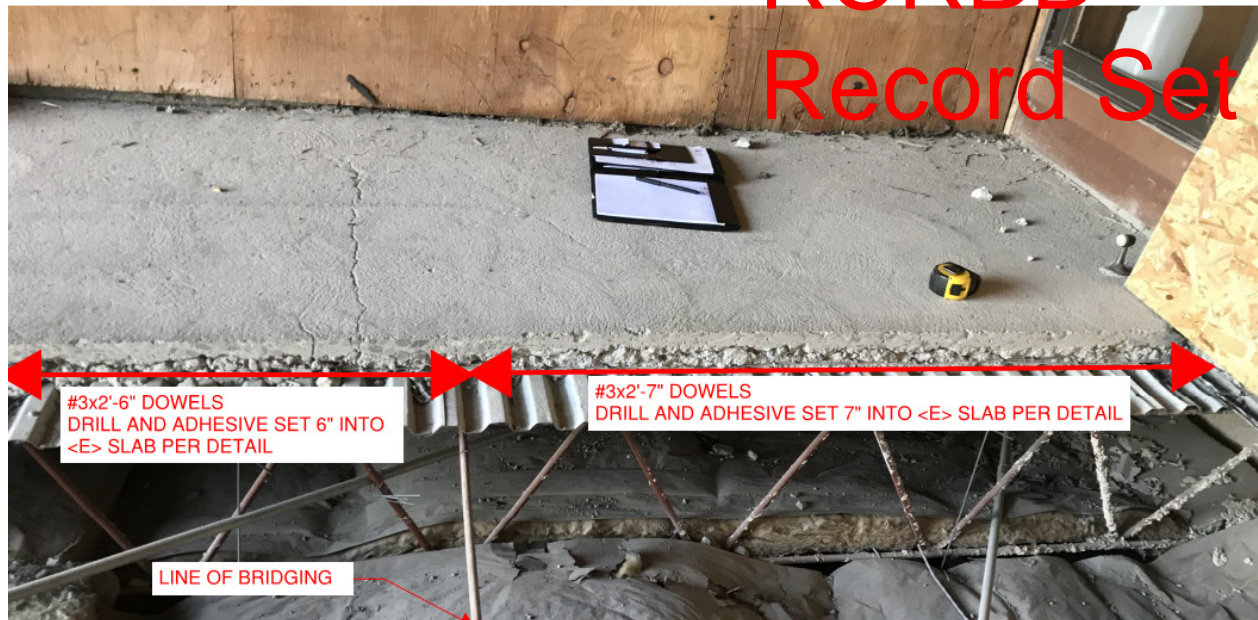
Exhibit A:

It is our opinion, that given the observed horizontal cracking within the slab section, the #3 dowel bars noted in the issued detail should extend an additional distance into the slab. The attached Exhibit A specifies our recommended embedment lengths of the new dowels. Exhibit B is an updated detail sketch of the repair.

Since we cannot observe anything other than surficial cracking, it is recommended that the Contractor contact Anthem in the event this crack is discovered to extend any further into the slab than the approximate 2" observed. The soundness of the concrete beyond the surface should be apparent during hammer drilling operations.
