**SUBSOIL AND FOUNDATION INVESTIGATION
THE WILD BLUE TERMINAL AND RESTAURANT
STEAMBOAT SKI RESORT
STEAMBOAT SPRINGS, COLORADO**

NWCC Project NO. 19-11550

July 29, 2019

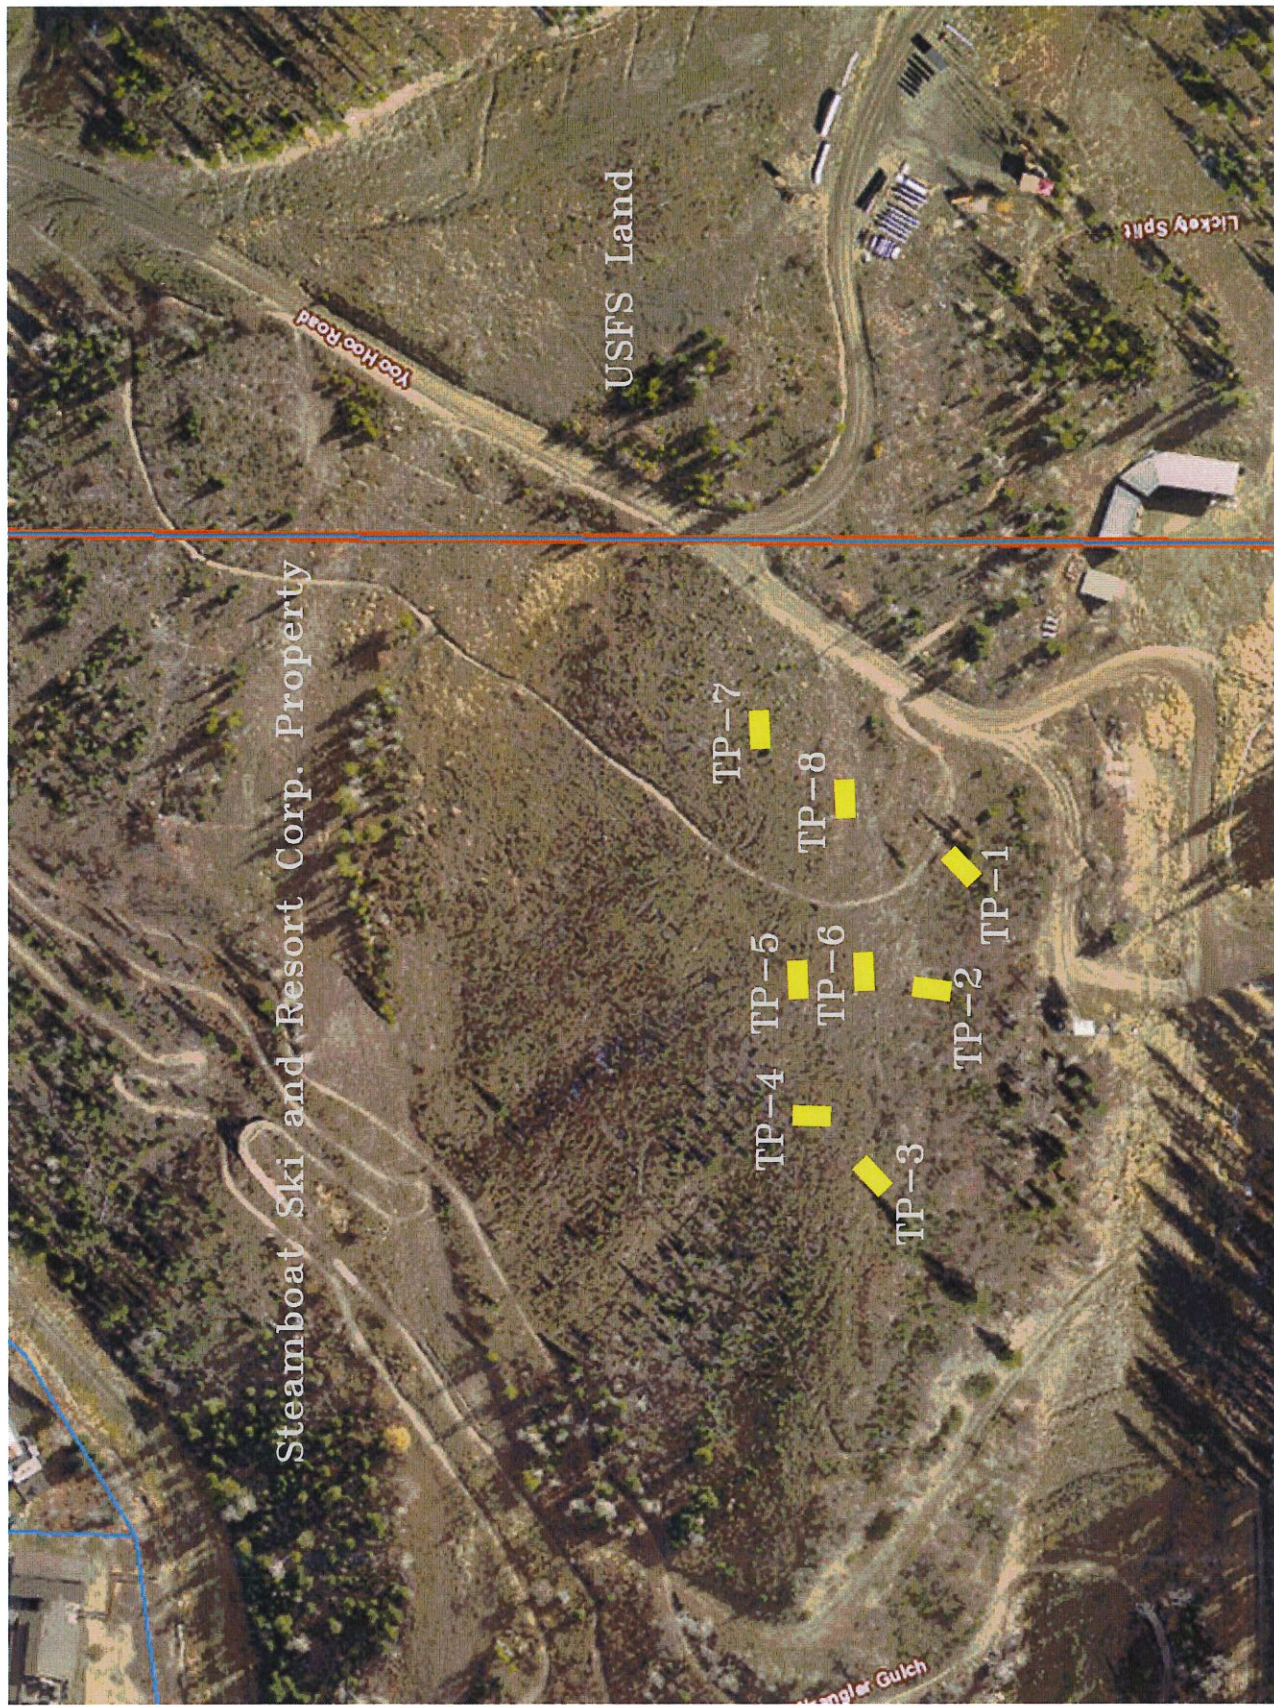
The field investigation was conducted on July 9, 2019. Eight (8) test pits were excavated at the approximate locations shown in Figure #2 using a CAT 320 E trackhoe provided by the client. Test pits were logged, and samples were obtained at the time of excavation by an engineer from NWCC. Graphic logs of the exploratory test pits are shown in Figure #3, and associated Legend and Notes are shown in Figure #4.
